SERVICE BULLETIN No. 300-1-92

Subject: Elevator Mass Balance

Models affected: EA-300

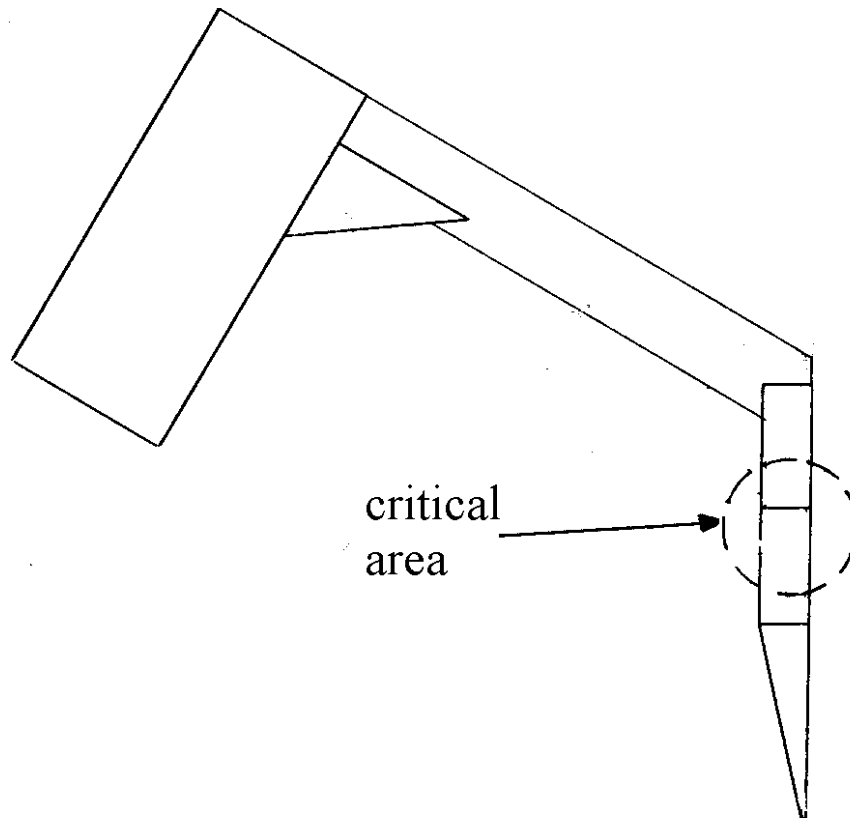
Figure 1. Elevator mass balance, critical areas for inspection:

Purpose: Cracks have been reported at the elevator mass balance support.

Compliance time: **I:** Inspection prior to next flight (inspect and dye-check elevator mass balance attachment plate. Exercise particular awareness at the areas shown in figure 1, if cracks are found inform EXTRA Flugzeugbau).

II: Change of mass balance prior to next 25hours in service or immediately in case cracks or deformations are found. No acrobatic flight prior to change of the elevator mass balance.

- Remove empennage fairing.
- Remove rudder and vertical stabilizer.
- Remove elevator mass balance.
- Install reinforced mass balance, PC-33202.1B using new stop nuts.
- Reinstall vertical stabilizer and rudder.
- Reinstall empennage fairing.
- Check control surface maneuverability.
- Make appropriate logbook entry of compliance with this Service Bulletin.
