SERVICE BULLETIN No. 300-2-94

Subject: Attachment of engine control bowden cables

Models affected: EA-300 EA-300/S

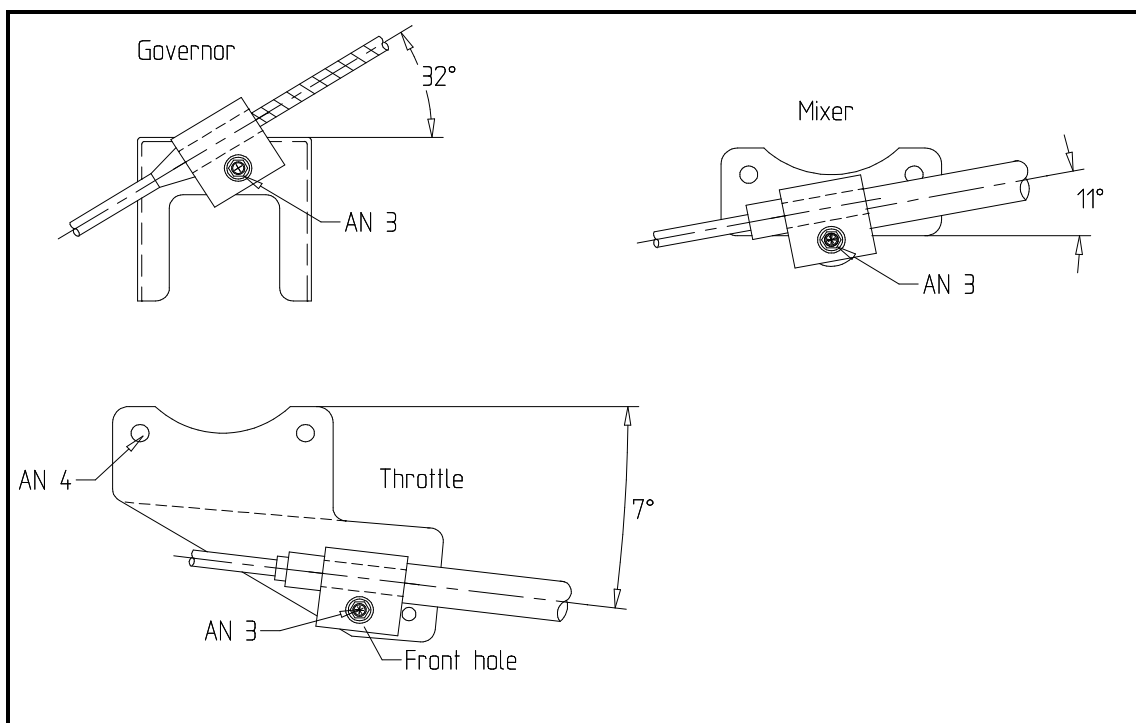
Purpose: The above mentioned attachment, due to insufficient bolt torque, could be subject to rotation. The subsequent missalignment leads to increased wear and bending of the bowden cable.

A proper function of the bowden cable depends on the angle between bowden cable clamp block and the attachment (refer to Figure 1). For this reason the respective alignment angle and the bolts torque of the AN 3-10A bolts has to be checked. The correct bolt torque value for the AN 3 bolt is 3.5 to 4.5 Nm (3-40in lbs).

Figure 1 Correct alignment angles

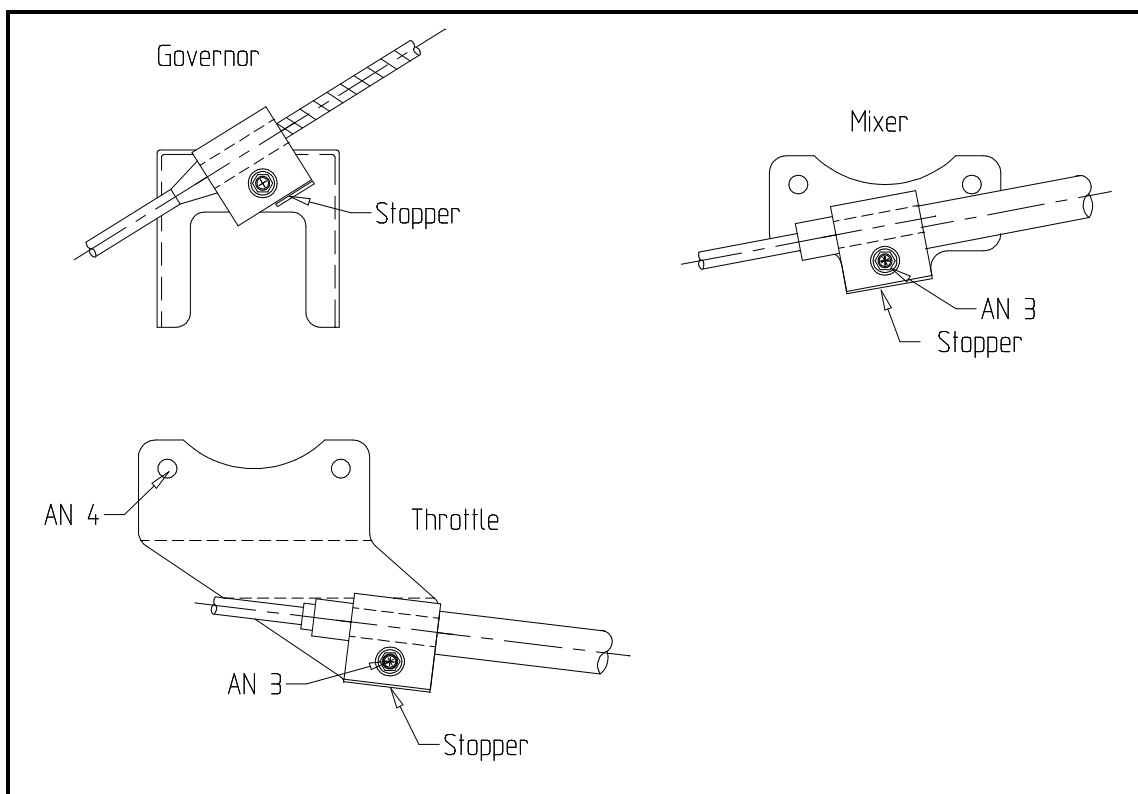
Figure 2 Modified attachments

- Disassemble the existing attachments (governor bowden cable attachment PC 63301.6, mixer bowden cable attachment PC 63301.4 and throttle bowden cable attachment PC 63301.5).

- Install the new throttle and mixer bowden cable attachment with AN 4 bolts MS20074-0406 (PN\ PC-01853) and DIN 125 M6 washers (PN\ PC-00417). Use new bolts and washers if necessary. Secure the bolts with safety wire.
- The governor bowden cable attachment has to be installed with AN 3-3A (PN\ PC-00202) bolts and DIN 125 M5 washers (PN\ PC-00416). Use new bolts and washers if necessary. Always use new AN 3 stop nuts MS20365-1032A (PC -02347).
- Mount the clamp blocks on the respective attachment using AN 3-10A (PN\ PC-02252) bolts, DIN9021 M5*20 (PN\ PC-00564) and DIN 125 M5 washers (PN\ PC-00416). Use new bolts and washers if necessary. Always use new AN 3 stop nuts MS21042-3 (PN\ PC-00802). Pay attention to the stopper at the attachment sheet (Refer to Figure A2). The proper bolt torque of the AN 3-10A is 3.5 to 4.5Nm (30-40 in lbs).
