SERVICE BULLETIN No. 300-3-94

Subject: Canopy Latches

Models affected: EA-300/S

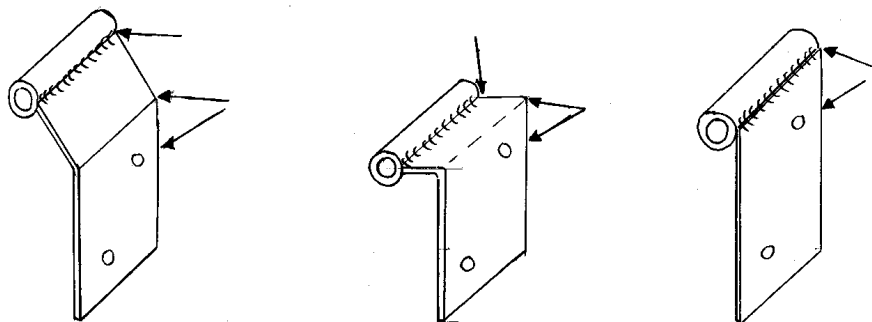
- Inspect all canopy latches which hold the lock and hinge sleeves for cracks at mounting bolt holes and at the adjustment bends of the latch as shown in figure 1. (So far only the front latches were reported to have failed. Cracks have not been reported from the rear latches.). Make sure the mounting bolt holes are round. Some latches unpermissibly have been modified with enlarged holes to adjust the fit a new canopy. New canopies need to be installed with new latches only.

- The latches (especially on the canopy side) commonly show cracks in the paint coating. Therefore the paint coating should be partially removed prior to structural inspection. Apply a corrosion preventive coating afterwards.

Fig 1. Potential crack areas of the latches

- In case cracks are found in the latches perform modification of the latches according to figure 2 or install new latches (P/N PC-23303.8P1 for both front latches and the rear right; PC-23303.8P2 for rear left).

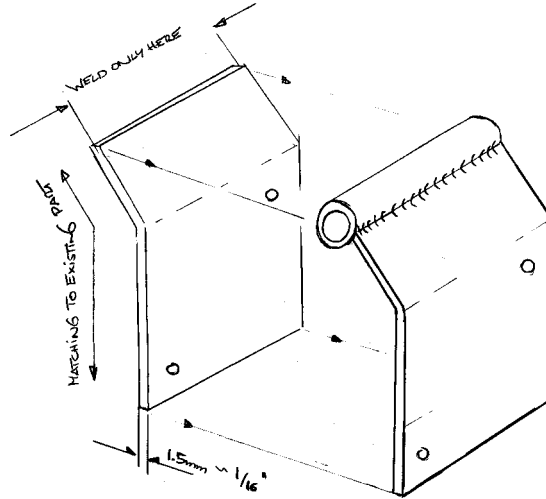
Fig. 2. Latch modification

- The latches are custom fit for every A/C. Hence new parts need to be trimmed for the specific application. When ordering new parts please exactly specify the dimensions of your latch (length, bend angle, and sleeve position). Reinforcements of old parts as shown in figure. 2 are to be custom fit as well.
- The modification and the new parts feature a doubled latch steel sheet to provide a redundant load path. Upon installation of the modified / new parts apply wax or penetrating oil to prevent corrosion between the two sheets.
- Make appropriate entry of compliance with this Service Bulletin in the aircraft logbook.

- For the modification use 1.7734.4 or 4130 steel, 1.5mm thick
- Weld reinforcing sheet to sleeve only
- Apply wax or penetrating oil between sheets
