SERVICE BULLETIN No. 300-1-95

Subject: Seat Attachment
Models affected: EA-300 EA-300S
Serial numbers affected: V1,01 through 63 01 through 22
Purpose: Cracks have been reported
Approval: The technical content of this Service Bulletin have been approved by LBA.

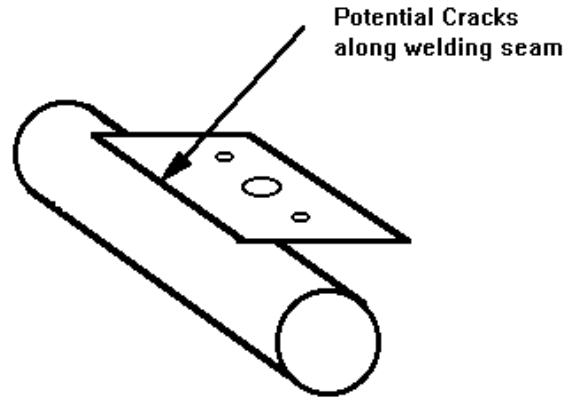
Fig 01 Potential Crack Area

- On EA-300 seat attachments front seat (wood and carbon seat) and rear seat (wooden seat only) as well as on EA-300S seat attachments cracks have been observed, refer to Fig. 01.
- In series production a modification has been introduced to strenghten the attachments.
- Operators and maintenance shops are advised to check for cracks at those attachments and to strenghten the attachments as shown on Fig 02.
