SERVICE BULLETIN

No. 300-2-95

Subject: Inspection of upper longeron at the horizontal stabilizer attachment.

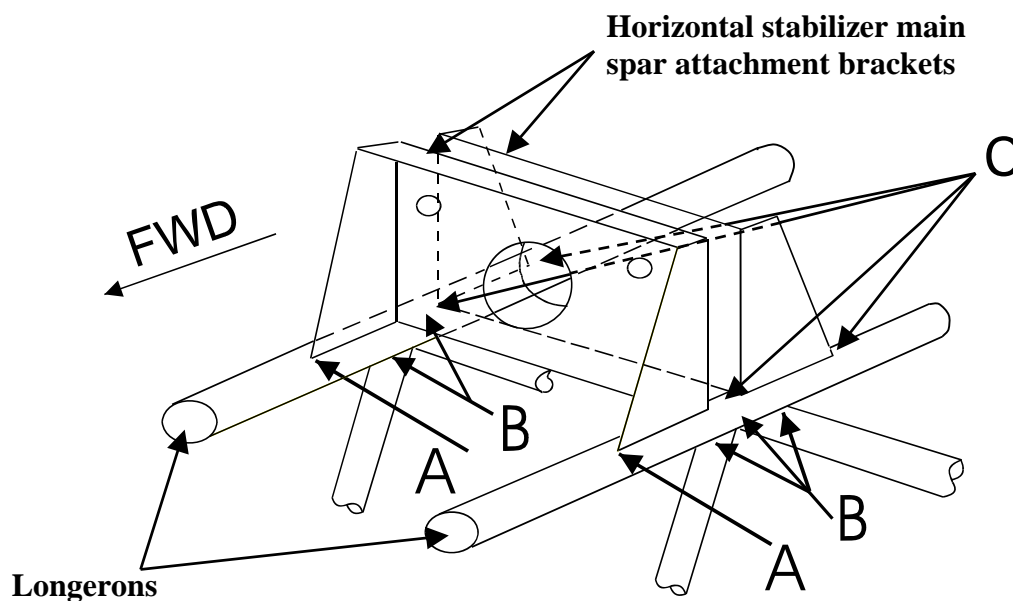
Purpose: Cracks have been reported on EA 300/S, EA 300/L and EA 300/200 airplanes that are frequently operated near or at the design limits. The cracks were found in the upper fuselage longeron and its welds in front of the horizontal stabilizer main spar attachment as well as between the attachment brackets. This Service Bulletin provides instructions for inspection and modifications in this area.

Figure 1: Possible crack locations in typical horizontal stabilizer attachments area.

- Remove tail fairing, rudder, vertical stabilizer, elevator, and horizontal stabilizer (see Chapter 27 and 55 of the Service Manual).
- Remove fabric from fuselage upper longeron in areas A, B and C as shown in Figure 1.
- Visually inspect these areas for potential cracks, particularly at welds.
- In case of doubt remove paint and use a dye check penetrant.
- If cracks are found proceed with the instructions of Part II.
- In case no cracks are found repaint tubing as required and reglue fabric. Reassemble the empennage according Chapters 27 and 55 of the Service Manual.
- Make appropriate logbook entry of compliance with the repetitive inspection according PART I of this Service Bulletin.

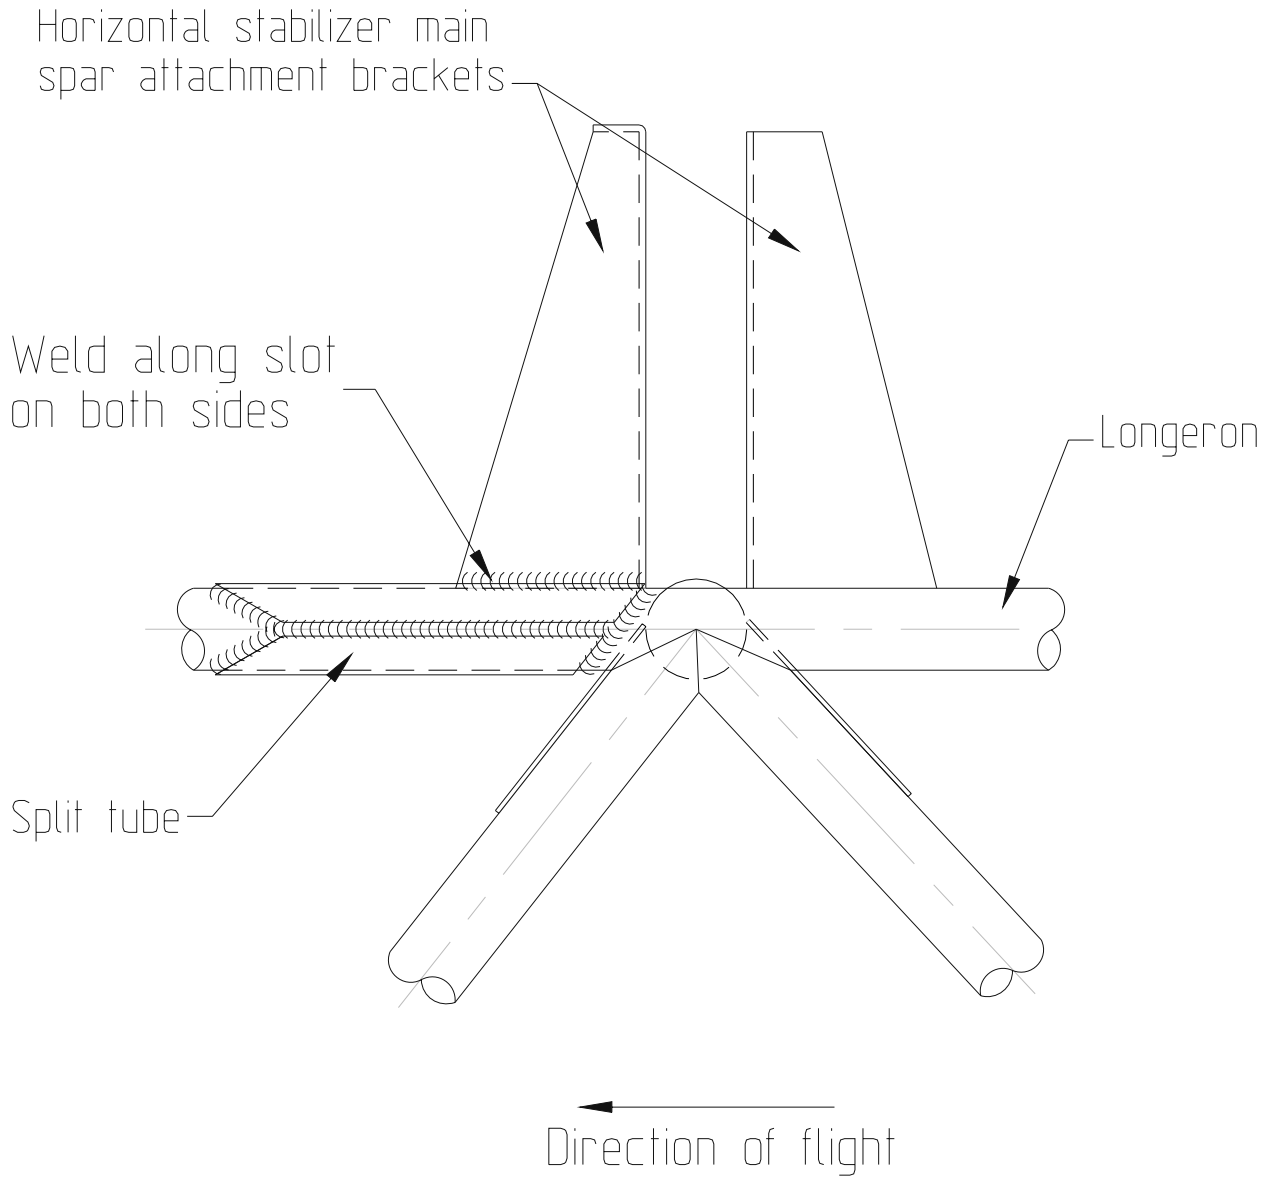
Figure 2: Typical installation of split tubes to repair crack in longeron.

- Weld any crack in areas A, B and C. Cracks in the longerons have to be repaired with sleeves (split tubes) according Figure 2, additionally.
- Prepare parts according applicable kit (see material allowance) and Figure 3 for welding. When split tubes are installed the contours of the reinforcement steel patch plate and the related gussets have to be adjusted slightly to match their surrounding structure.

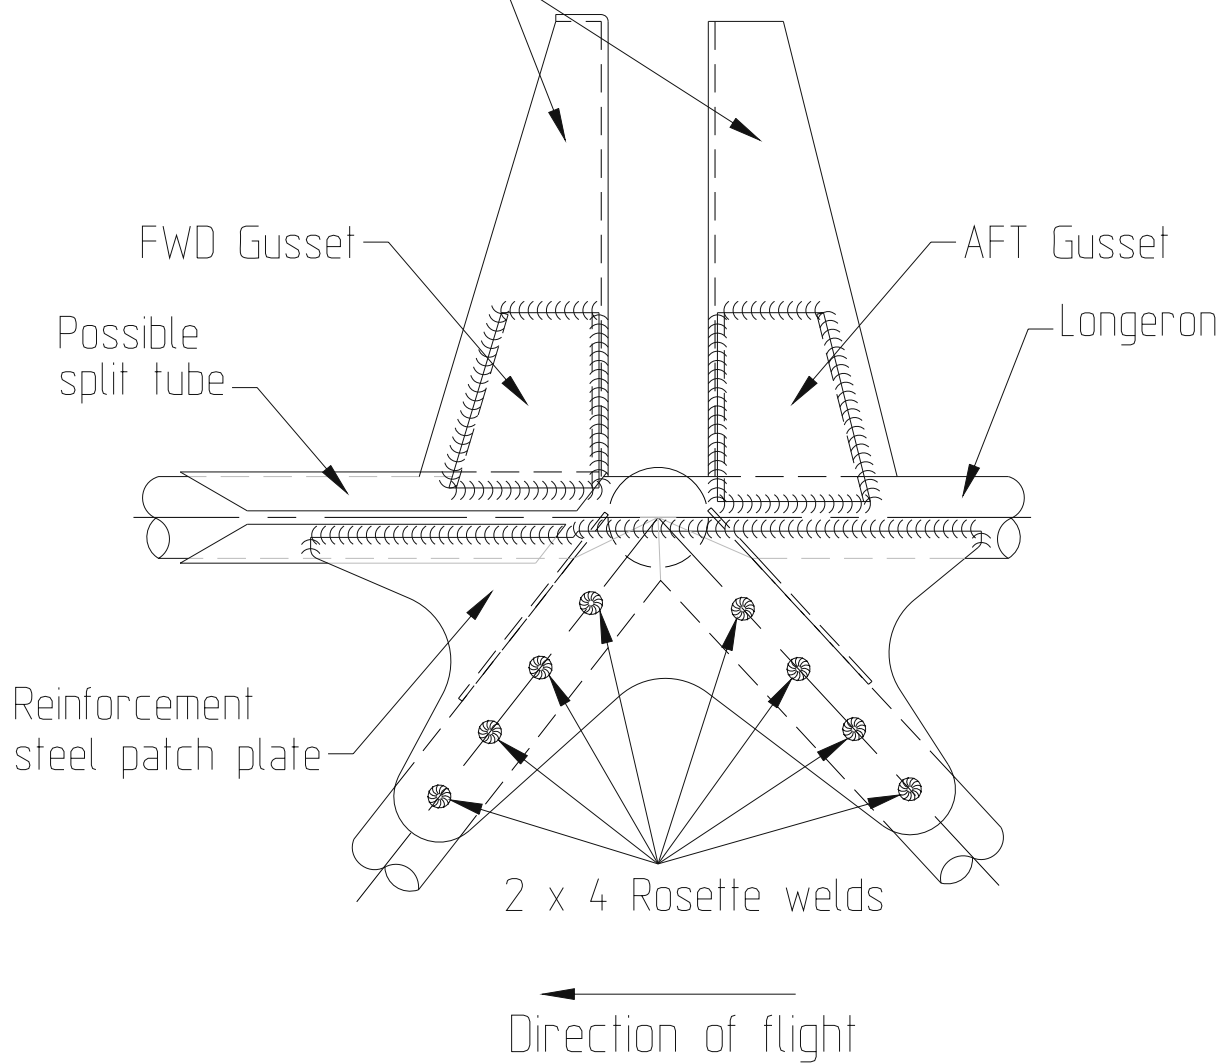
Figure 3: Typical installation of reinforcements in area around horizontal stabilizer main spar attachment brackets (view on left side).

- Weld parts in place according Figure 3.
- Remove bushings and check for welding shrinkage.
- Reinstall horizontal and vertical stabilizer and check proper alignment of tail surfaces with respect to the wing. Remove stabilizers again.

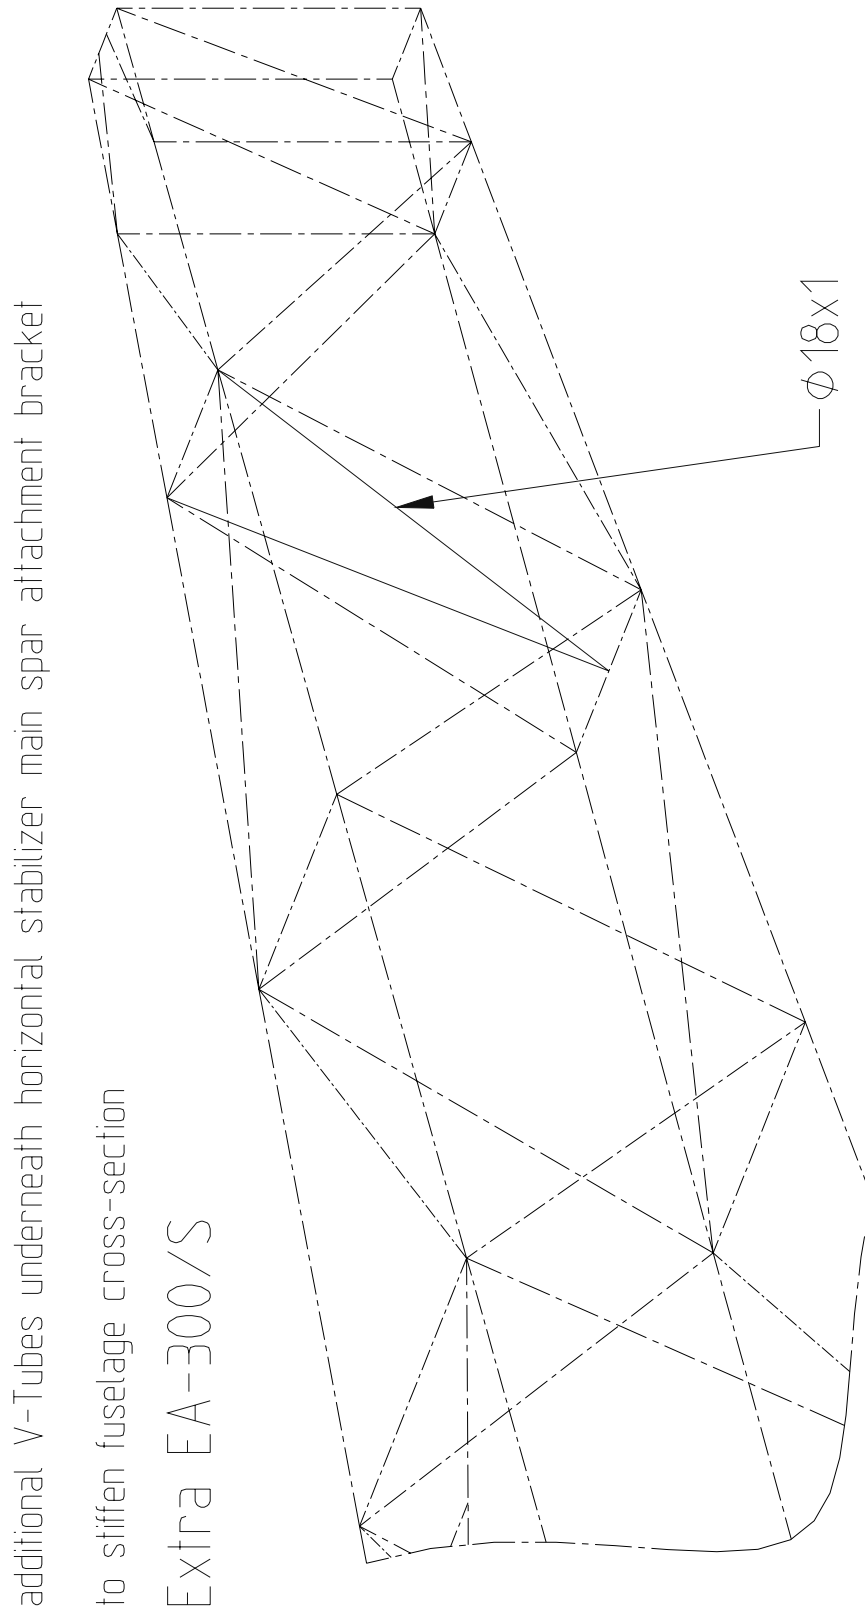
Figure 4: Additional V-tubes in EA 300/S fuselage steel tube frame.

- Make sure the V-tubes match the existing structure according to the applicable Figures (see Table 2).

- For the protection of the tube interior fill a small amount of corrosion preventive compound like ACF-50 or equivalent into each of the V-tubes.
- Weld V-tubes in place and check proper fit of gussets according to the applicable Figures (see Table 2) and weld them in place.

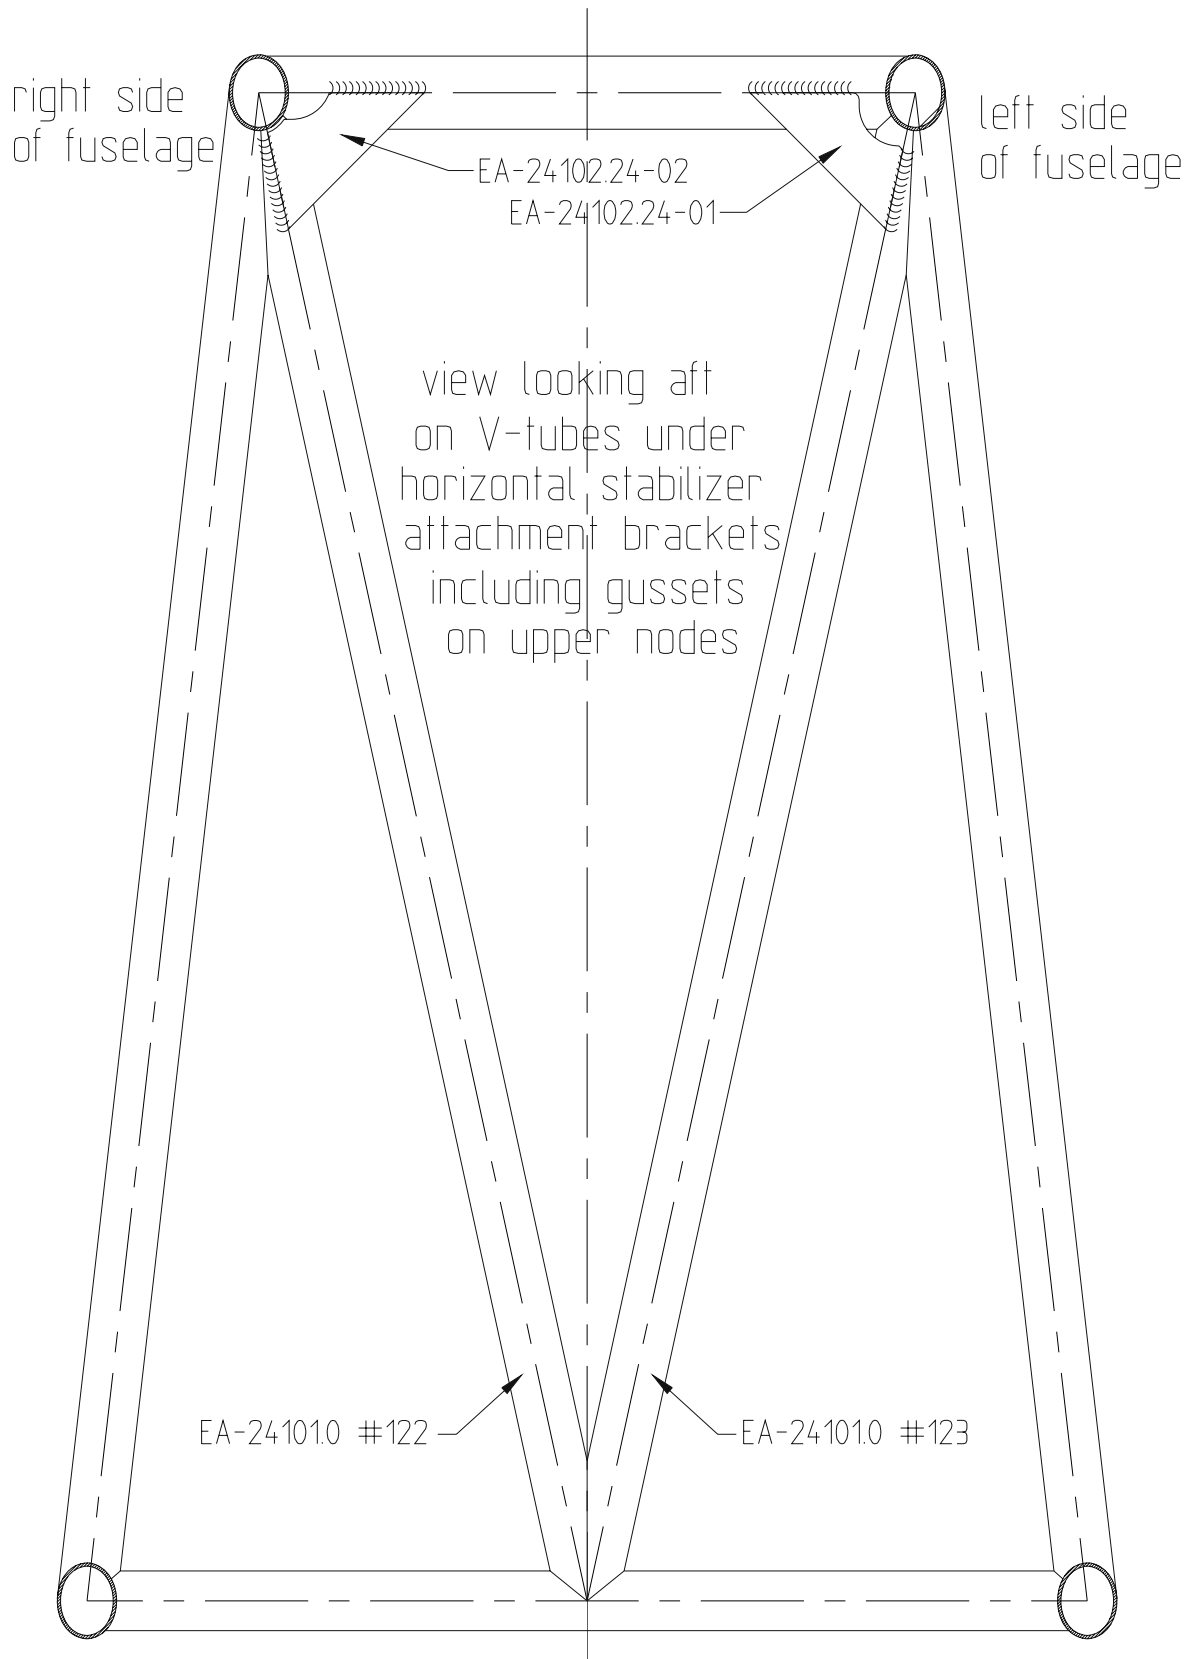
Figure 5: V-tubes and gussets for EA 300/S (Kit No. SB295E3-1).

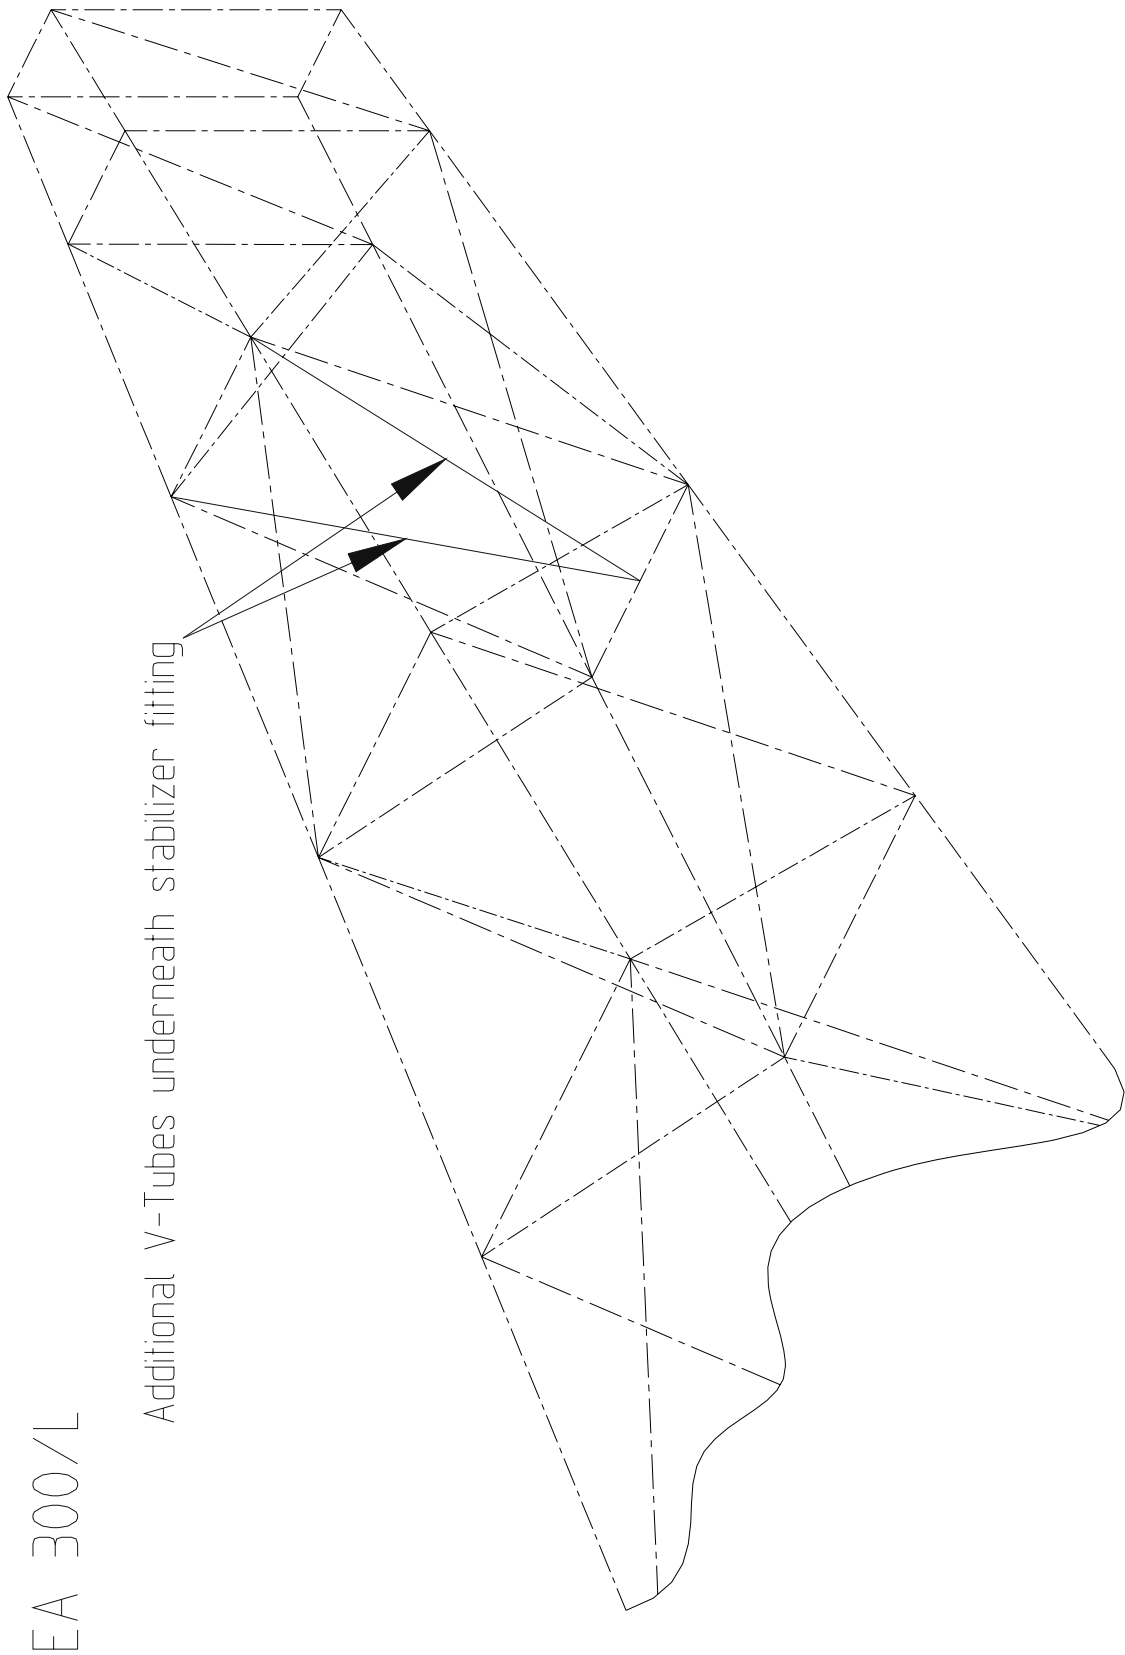
Figure 6: Additional V-tubes in EA 300/L fuselage steel tube frame.

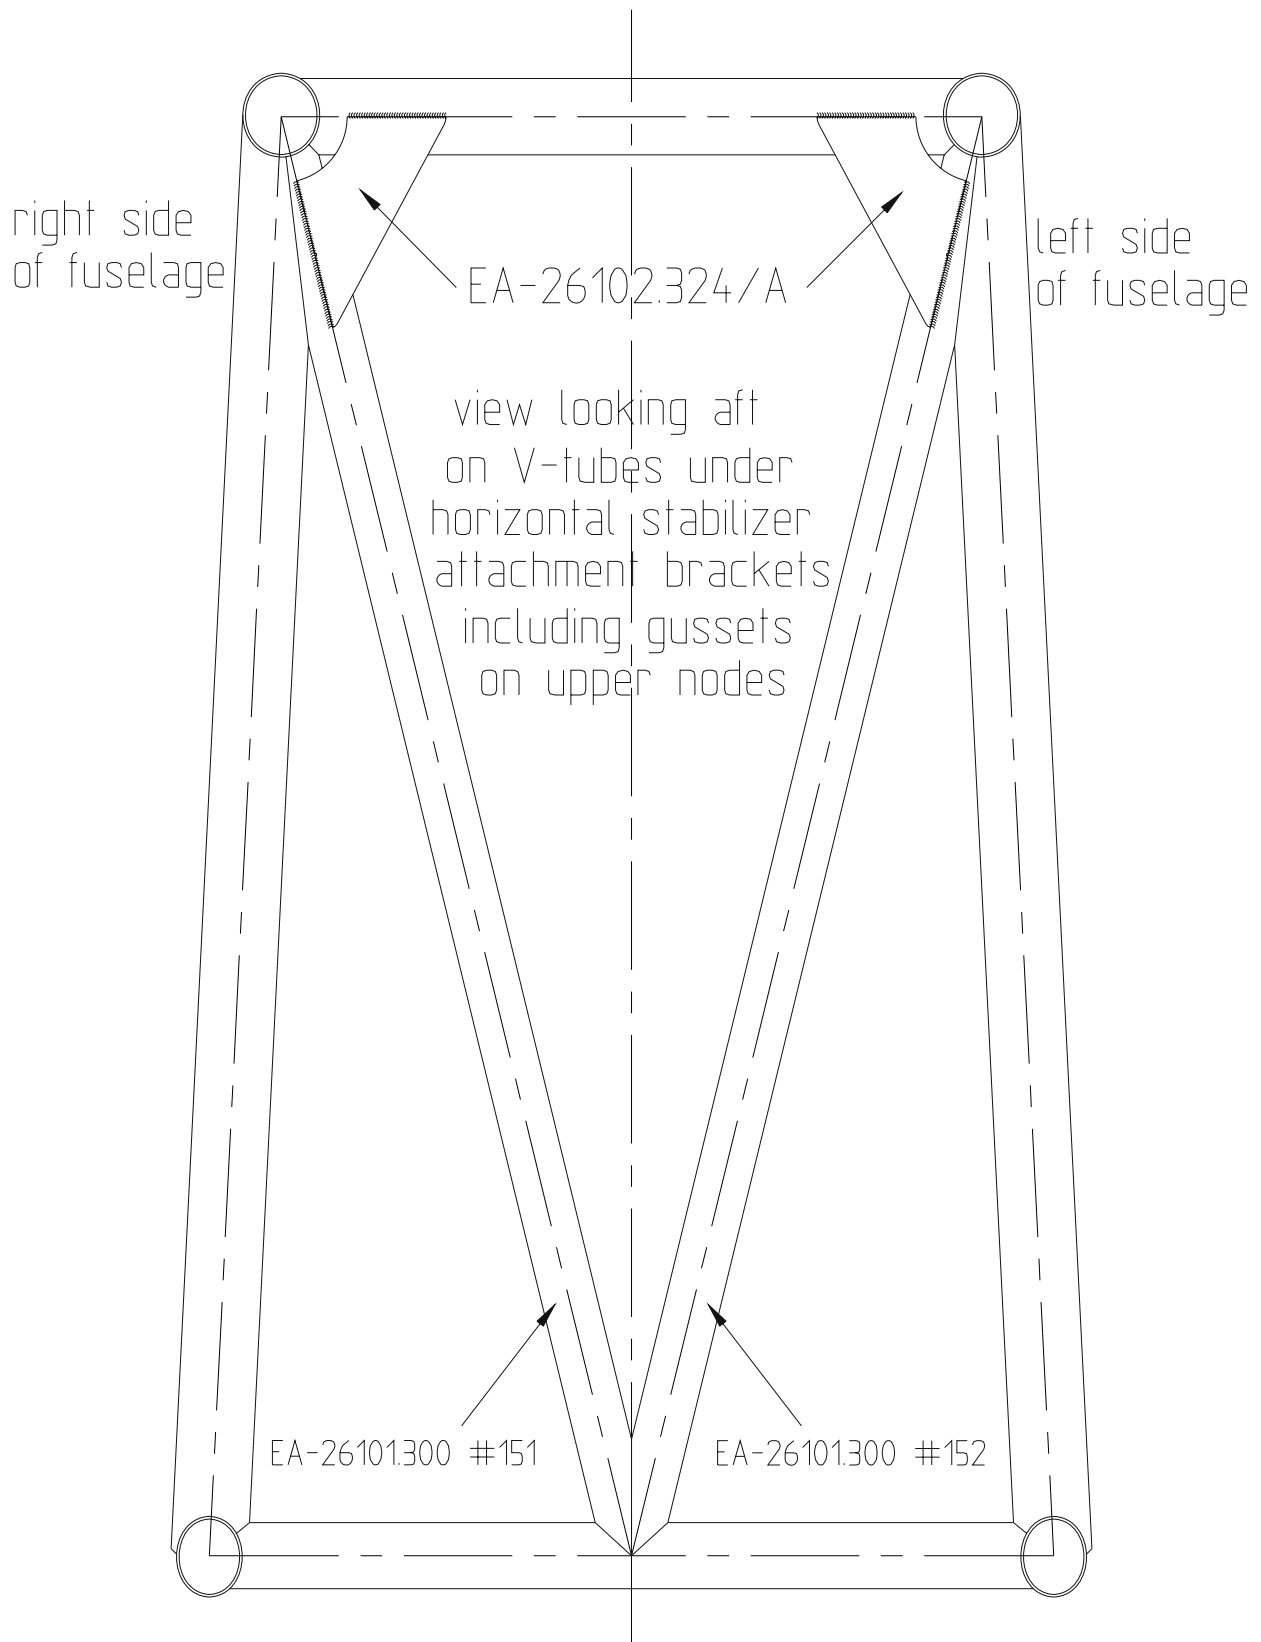
Figure 7: V-tubes and gussets for EA 300/L in 4130n (Kit No. SB295E3-2).

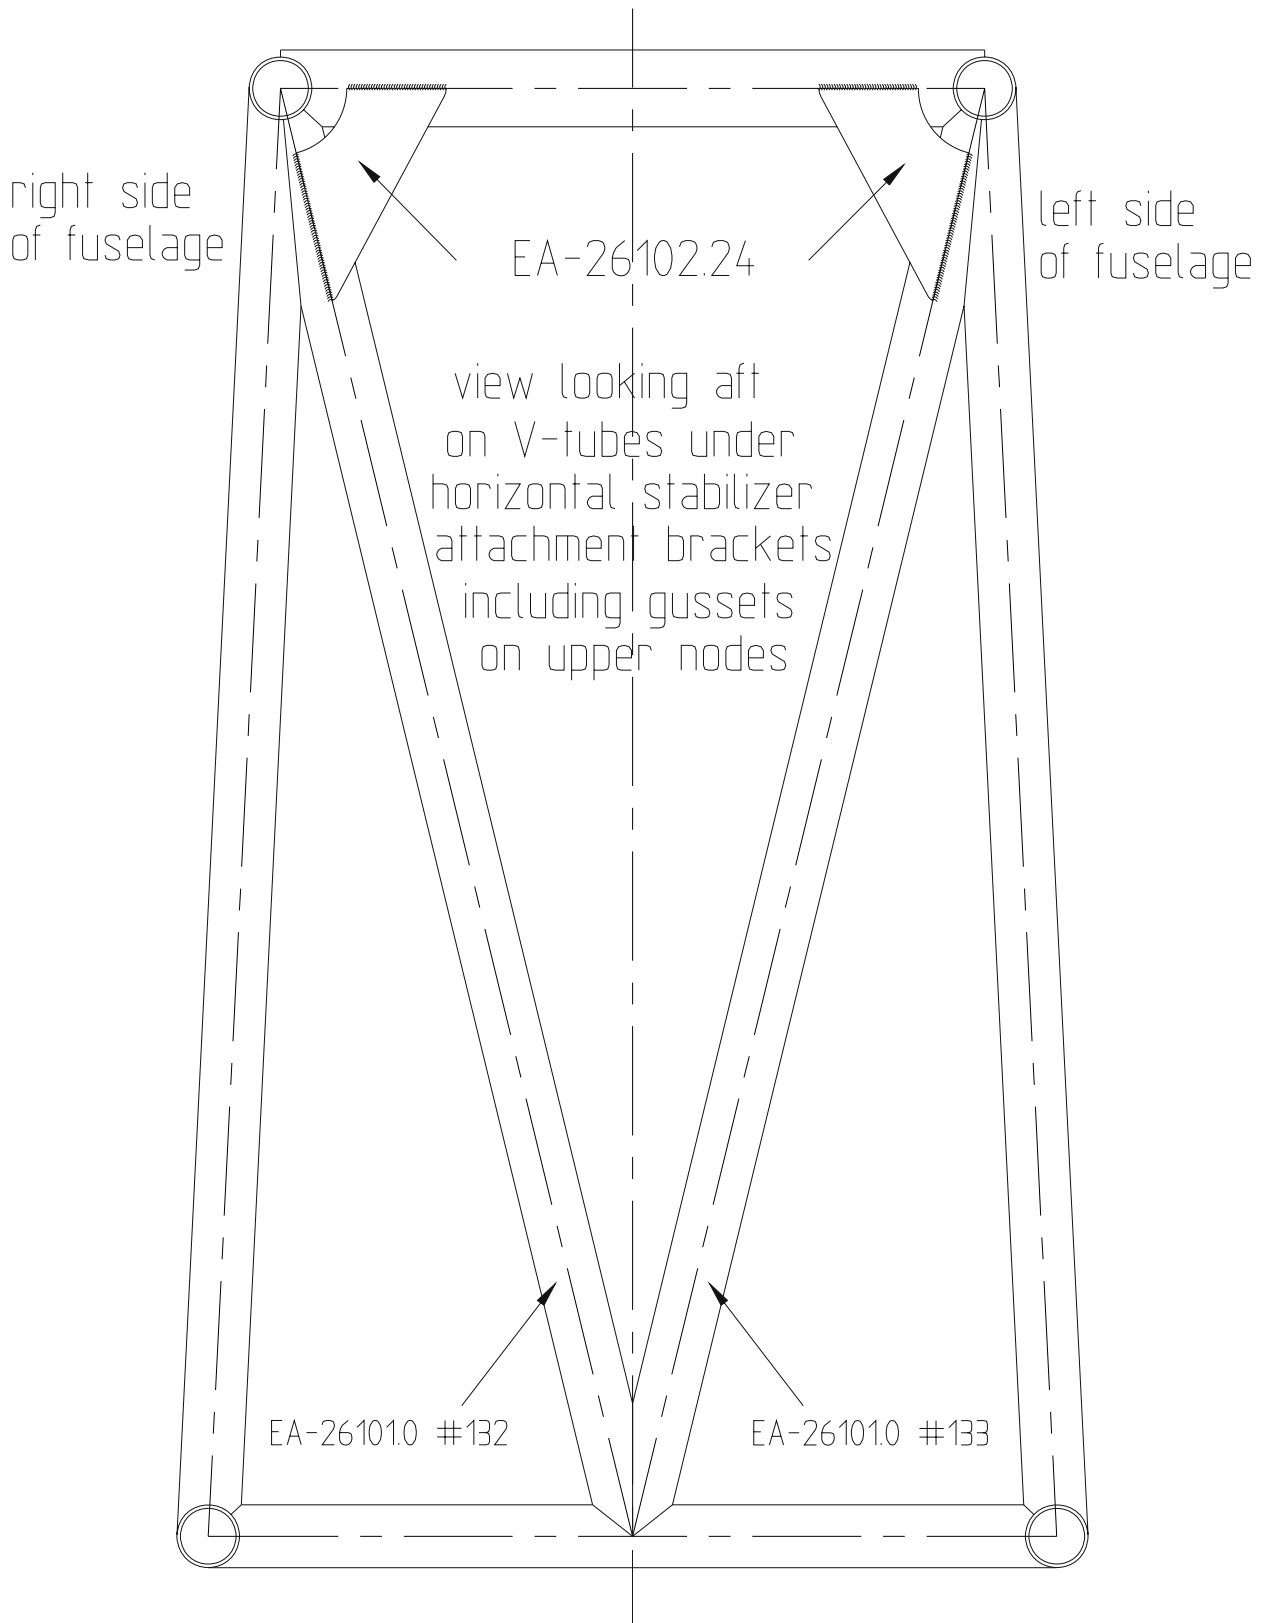
Figure 8: V-tubes and gussets for EA 300/L in 1.7734.4 (Kit No. SB295E3-3).
