## SERVICE BULLETIN No. 300-1-96

Subject: Additional aileron hinge

Models affected: EA-300 EA-300/S EA-300/L EA-300/200

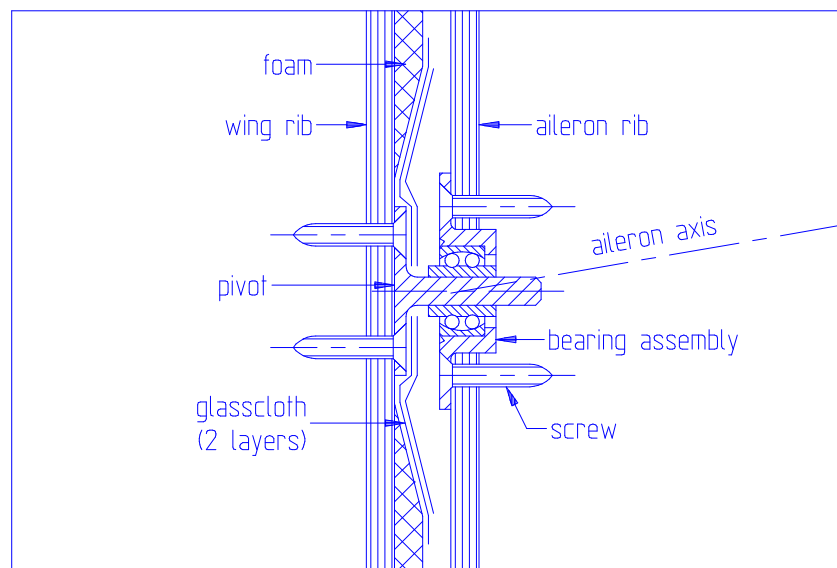
Purpose: A resonance vibration of the aileron's inner end under special circumstances (high g loading at speeds above 180kts) has been reported. The modification described below is only advisable for those aircraft suffering from the same phenomenon.

- Remove the aileron from the wing according to the instructions in the S/M.
- Drill a 24mm (15/16") dia. hole at the center spot of the aileron rib.
- Remove the paint and the foam on the wing rib within a diameter of about 40mm (1.6") around the center mark until the plywood rib is exposed. (EA-300 wings up to S/N33 feature no foam filling.)

- Mix epoxy resin L20 with hardener SL (see S/M chapter 57-30-01) and add about 20 per cent weight of flocked cotton fibers in order to produce a viscous, non-dripping glue. Glue the bearing assembly (PC-13105.12) into the oversize hole, using enough epoxy to fill the gap. Look out that the bearing remains free from glue. Put the pivot (PC-13105.11) into the bearing, then immediately mount the aileron to the wing.

- Before the epoxy starts to cure, gently move the aileron up and down a few times to make sure that the bearing is aligned with the other three bearings. Fasten the pivot provisionally in the proper position on the wing rib.
- Let the epoxy cure according to the instructions in S/M chapter 51-70-02, then remove the aileron again.
- Screw down the pivot and the bearing by means of 4 self-tapping screws each. Then secure the pivot by laminating 2 layers of glasscloth type 92125 over the pivot and the whole surrounding surface.
- Paint the affected surfaces.
- Check the aileron balance according to S/M chapter 51-60-01, then mount the aileron again. Review the aileron deflection angles (see S/M).
- Make appropriate entry of the retrofit in the aircraft logbook.
