SERVICE BULLETIN

No. SB-300-2-97

- Subject:** Fuselage structure / tail spring support
- Aircraft affected:** Following models and SN
EA-300/L: S/N 012, 014-170, 172, 173 and
1171, 1174-1299
EA-300/200: S/N 01-31 and 1032-1043
Aircraft that comply with Part II of issue (C) of this service bulletin are not affected.
- Purpose:** The combination of a redesigned tail spring support, a stiffer tail spring and rough field operations has led to cracks in the tail spring support mounting base.
Cracks have been reported even for airplanes that comply with PART II of the previous issue (A) of this service bulletin.
This issue D of the service bulletin is technically identical to issue C and provides instructions for recurring inspection and modification in the area of the tail spring support.
- Approval:** The technical content of this document is approved under the authority of DOA Nr. EASA.21J.073.

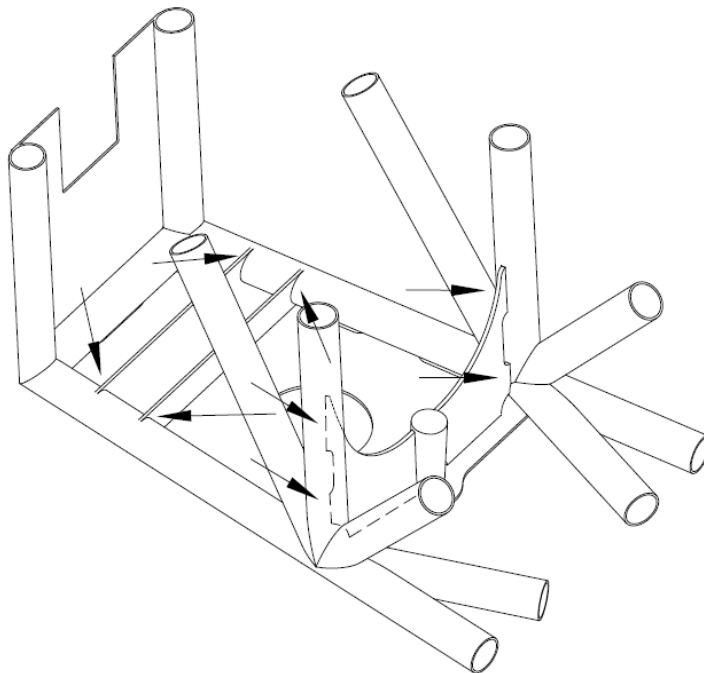
- Remove elevator control inspection window
- Visual inspection of tail spring mounting along welds to fuselage tubing. Cracks have been reported at the spots marked in figure 1. Investigate these areas carefully. To assist the visual inspection it is helpful to use a torchlight and a magnifying glass.
- In case cracks are found proceed with the instructions of PART II.
- In case no cracks are found reinstall elevator control inspection window and make appropriate entry of compliance in aircraft logbook.

Figure 1: Possible crack locations in the area of tail gear spring attachment (retrofit plates of SB-300-2-97 issue A installed)

In case the inspection described in PART I reveals cracks, PART II needs to be complied with prior to next flight.

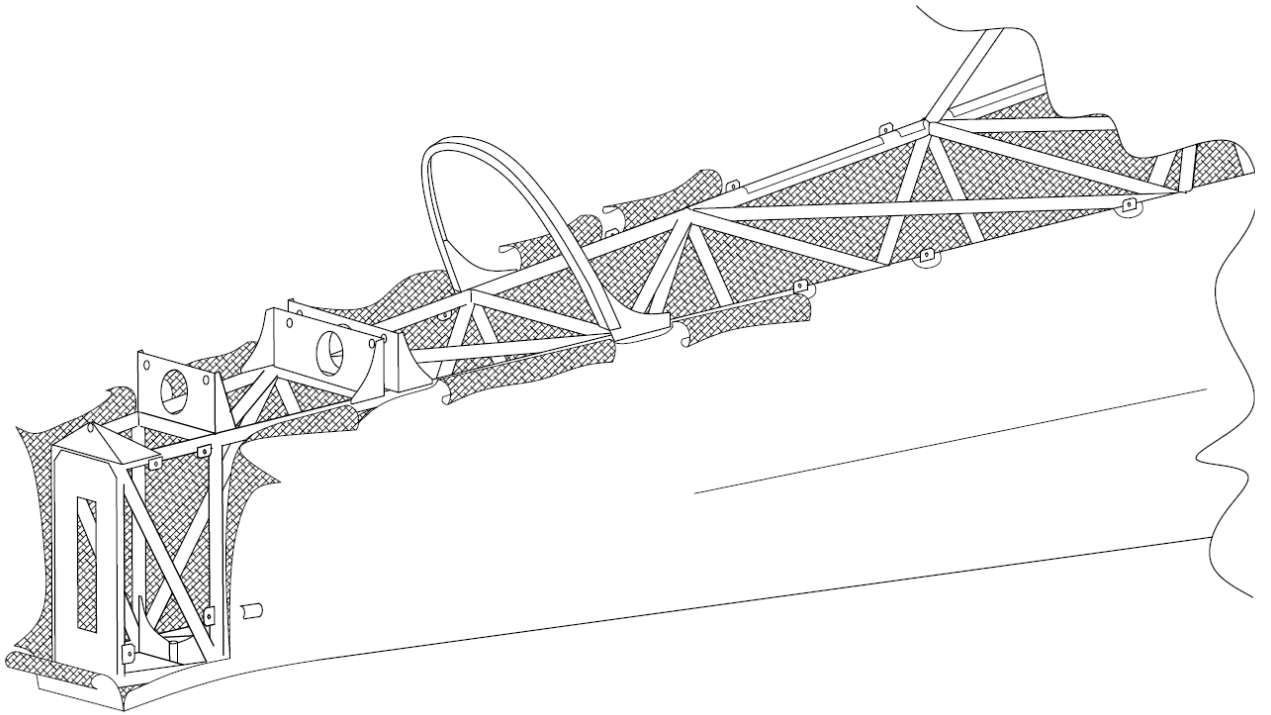
Figure 2: Removing the fabric

- Remove tail spring assembly, according Chapter 32 of the Service Manual.
- Disconnect battery ground wire and engine ground wire to firewall.
- Peel off fabric from upper L/H and R/H longeron, from rear facing fuselage surface and R/H lower longeron in the area of the inspection window (refer to figure 2 for detailed sketch). Do not use sharp objects that could damage the fabric while peeling it off. Fold the fabric far enough forward to have sufficient access to the area for welding. Make sure to work gently in order not to introduce cracks in the fabric paint coat finish.

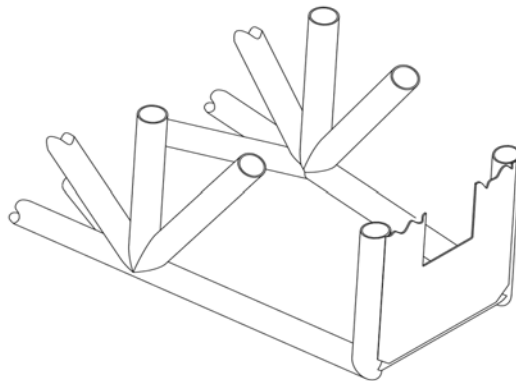
Figure 3: Cutout for crack repair and retrofit

- Cut out tail spring mounting plate including front and rear stiffener (figure 3 shows detail of rear truss after cutting). Proceed with caution. Avoid damaging any truss tubes (except those tubes that are replaced).

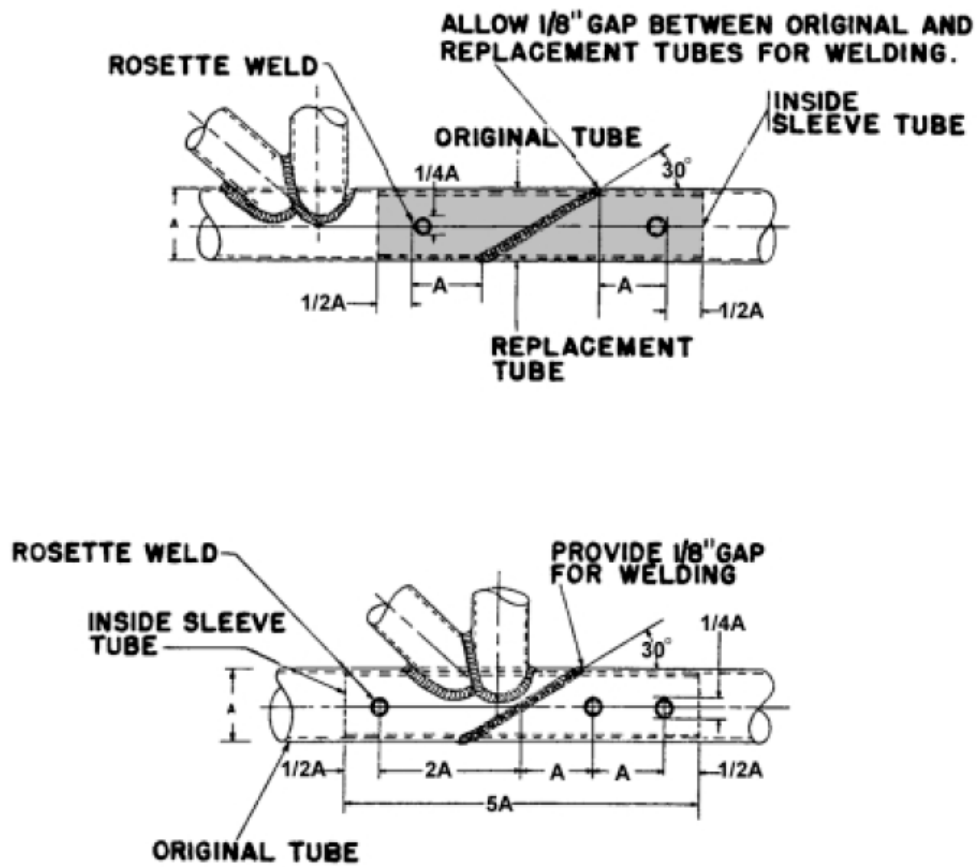
Figure 4: Method of inner sleeve splicing, recommended for tubing crack repair
(ref. AC 43-13-1B, Aircraft Inspection and Repair, Chapter 04)

- Repair any cracks found. Refer to Chapter 51-70-05 "Structural Repair of Steel Components" of the Service Manual and figure 4.
- Weld retrofit plates in place, refer to figure 5 for correct position of plates and welds.

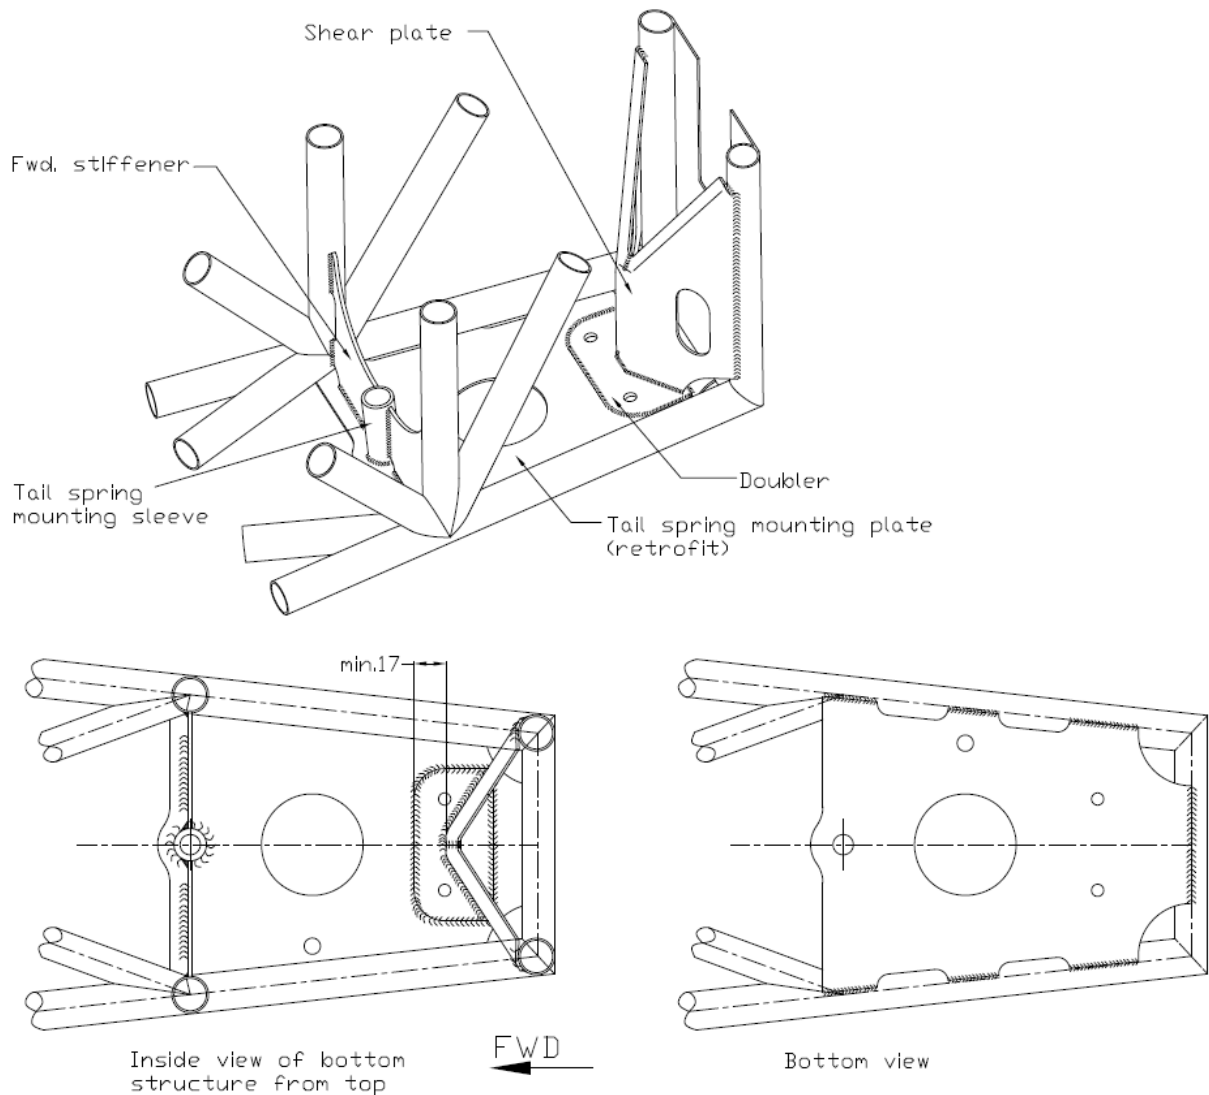
Figure 5: Position and welds of retrofit kit
