SERVICE BULLETIN

No. 300-1-05

Subject: Engine fuel pump vent

Affected Aircraft:	EA-300	S/N	V1, 1 through 67
	EA-300/S	S/N	1 through 31 and 1032
	EA-300/L	S/N	1 through 167, 168 through 170 (or converted to 1168 through 1170), 1171, 172 (or converted to 1172), 173 (or converted to 1173), 1174 through 1199 and 1201 through 1203

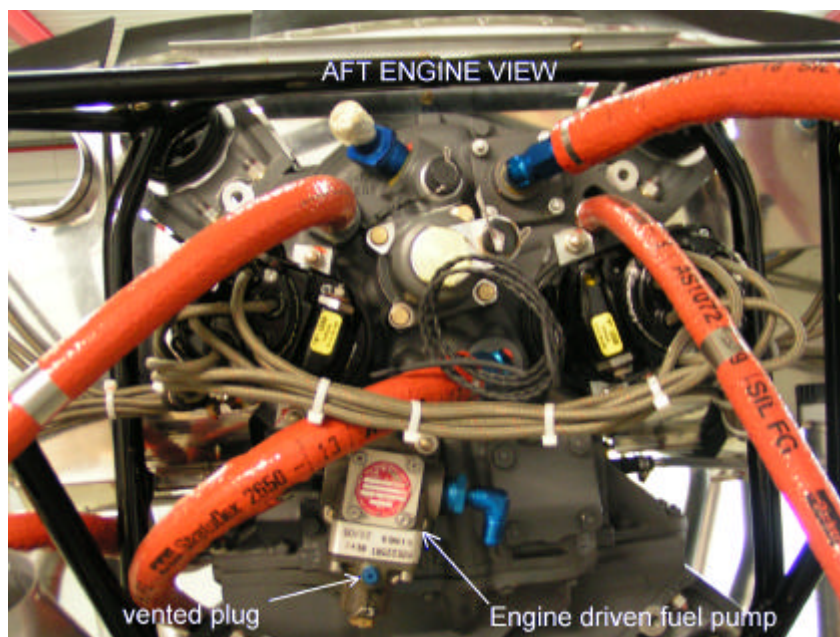
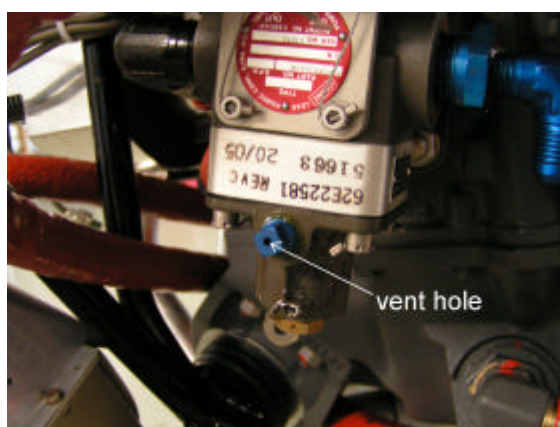
1. Inspect whether correct fitting is installed through opening in lower cowling. It may be necessary to remove the cowling. The engine driven fuel pump is located on the aft side of the engine just below the magnetos. The vented plug is positioned at the valve cover on the lower part of the pump and points aft. The fitting must have a vent hole though its axis. If the vent hole is present, no further action is needed.

2. If a plug without vent hole is installed, it must be removed and replaced by a vented plug Lear Romec P/N RA9087 or a modified MS20913-1D.
3. To modify a standard MS20913-1D (formally AN913-1D) drill an axial hole of 2 mm (1/16 inch) through the fitting.
4. Re-install removed cowling.
5. Fill out Appendix of this SB and send to
