## SERVICE BULLETIN

No. 300-1-06

- Subject:** **Repositioning of Single Oil Cooler**
- Affected Aircraft:** EA 300/S and EA 300/L aircraft equipped with the single oil cooler system manufactured before May 2006.

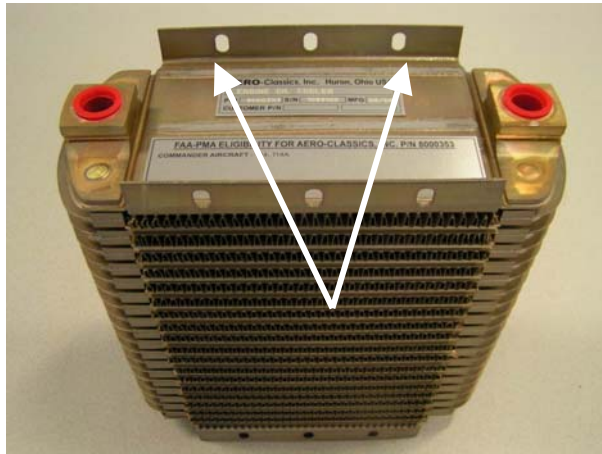
- Disconnect battery ground wire and engine ground wire to firewall.
- Disconnect and remove oil cooler.
- Check oil cooler for cracks, especially around the attachment flanges, see Figure 1.

Fig. 1: Oil cooler, typical crack locations

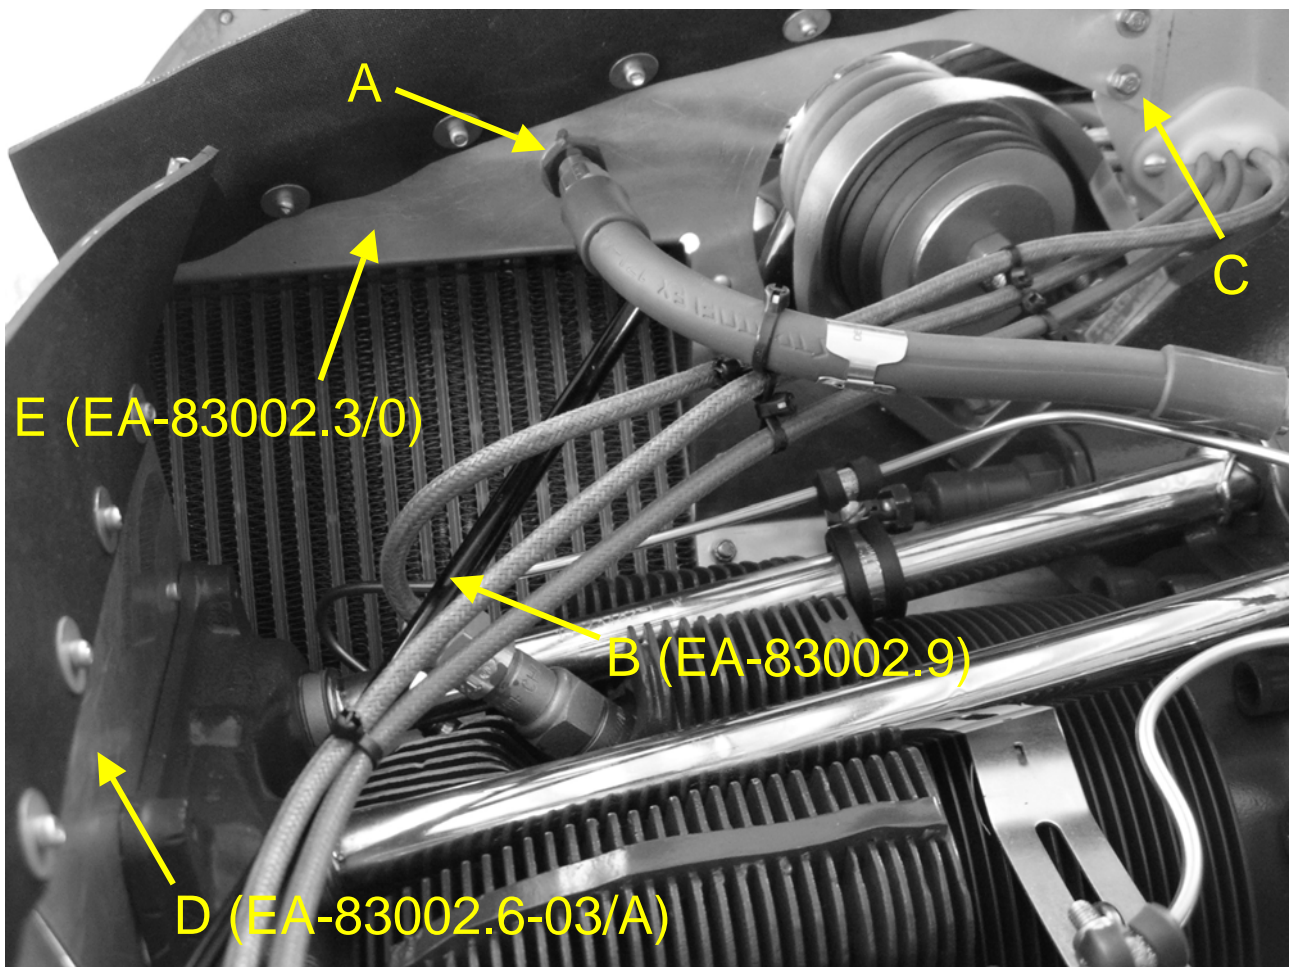
Fig. 2: Front View Current Oil Cooler Installation.

- Disconnect fuel sensing lines at RH AFT cooling baffle and remove bulkhead fitting, point A in Figure 2 (the AN832-4D bulkhead fitting is not needed for the new installation).

- Remove rod EA-83002.9, point B in Figure 2 (not needed for the new installation).
- If installed, also remove reinforcement rod on outside head cooling baffles, see Figure 7 (not on all aircraft, not needed for new installation).

- Remove bolts connecting the AFT middle baffle (P/N EA-83002.7) to the RH AFT baffle (P/N EA-83002.3), refer to connection C in Figure 2. Disconnect the threaded rods on the underside from the RH AFT baffle (P/N EA-83002.3), see Figure 4.

- Remove baffles EA-83002.6-03 index A and EA-83002.3 index 0 including attached rubber flanges, respectively points D and E in Figure 2 (not needed for the new installation). Pre-cut the rubber flange attached to the cylinder head baffles between Cylinders No.3 and No.5 just FWD of the most FWD rivet position on the baffle on Cylinder No.5, see Figure 4.

- Mark the position of the holes (for point C in Figure 2) in the middle baffle (P/N EA-83002.7) on the RH AFT baffle (P/N EA-83002.3). Remove assembled baffles and drill holes (Ø4mm / Ø5/32", Drill Size #21) in the marked locations in the RH AFT baffle (P/N EA-83002.3).

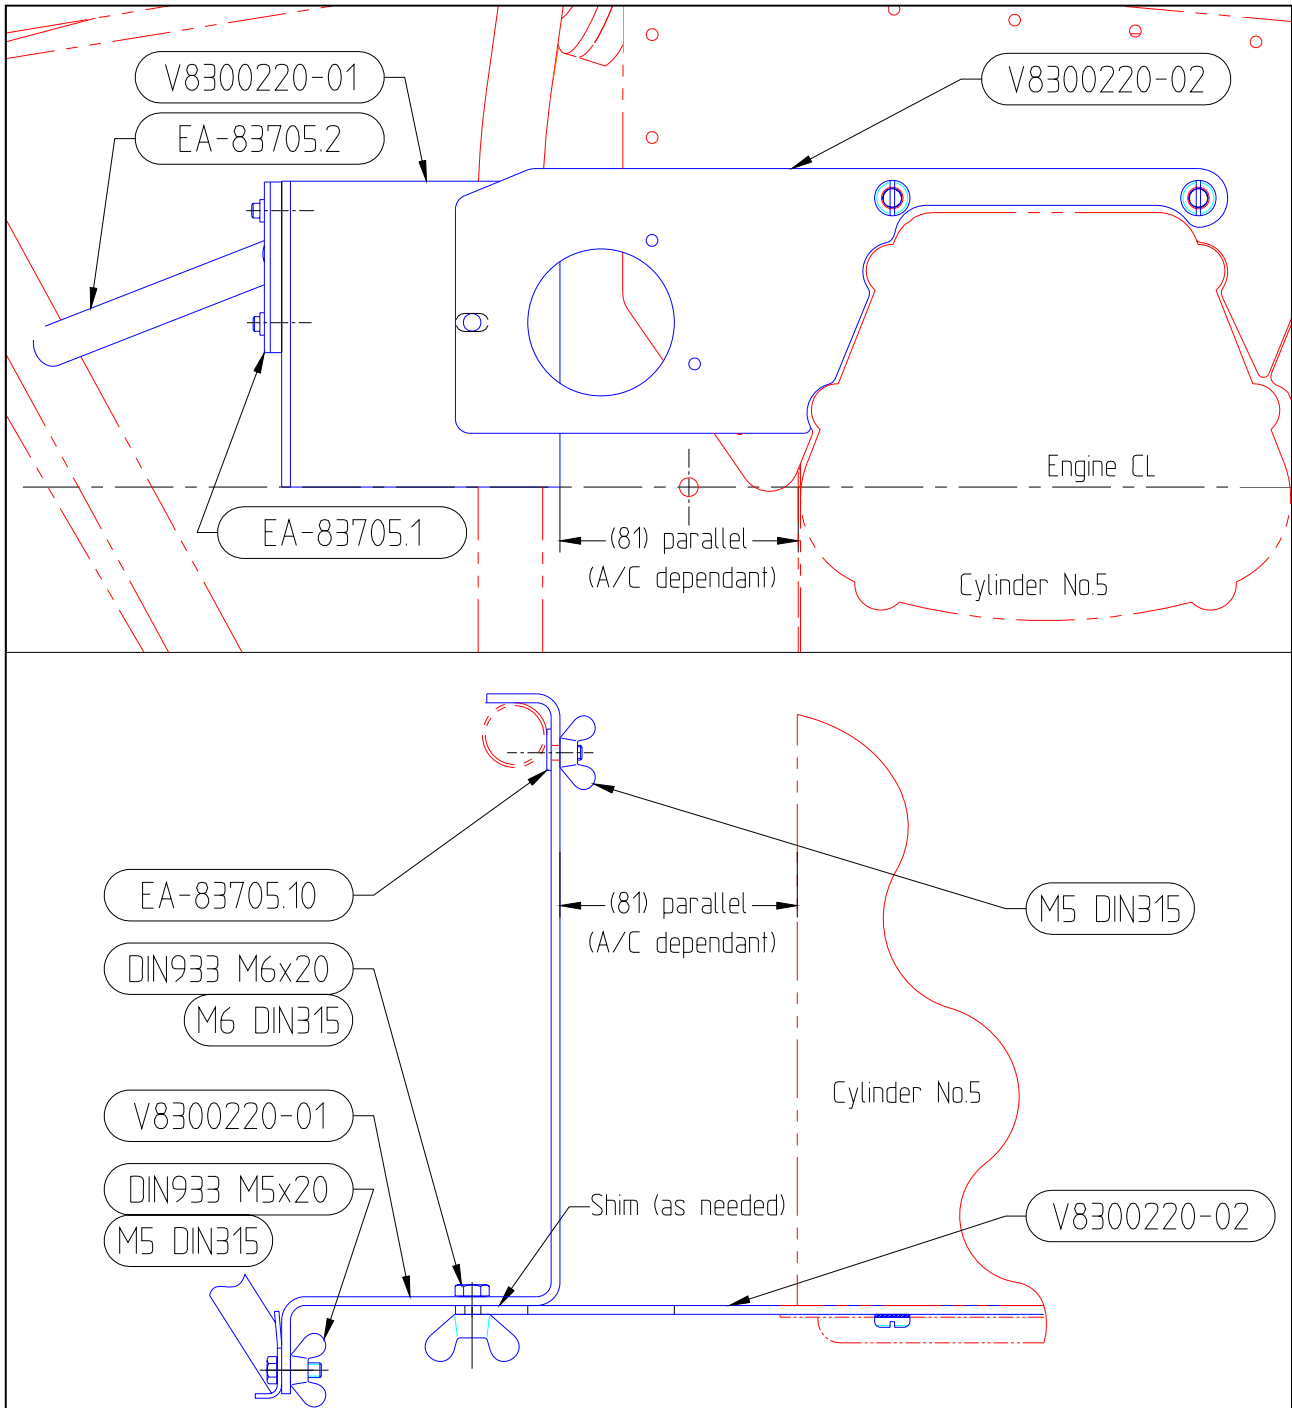
Figure 3: Side and top view of jig installation.

- Remove paint on engine mount in the areas where the new oil cooler LH oil cooler attachment bracket (P/N EA-83705.10) and tube (P/N EA-83705.2) will be welded to, see Figure 3 & 4.

- Bolt the LH and the RH oil cooler attachment brackets (P/N EA-83705.10 & EA-83705.1) to the jigs (P/N V8300220-01 & -02) with the supplied wing nuts (P/N M5 & M6 DIN315). Install

jigs according to Figure 3. On some aircraft it may be necessary to shim the two jigs for correct alignment.

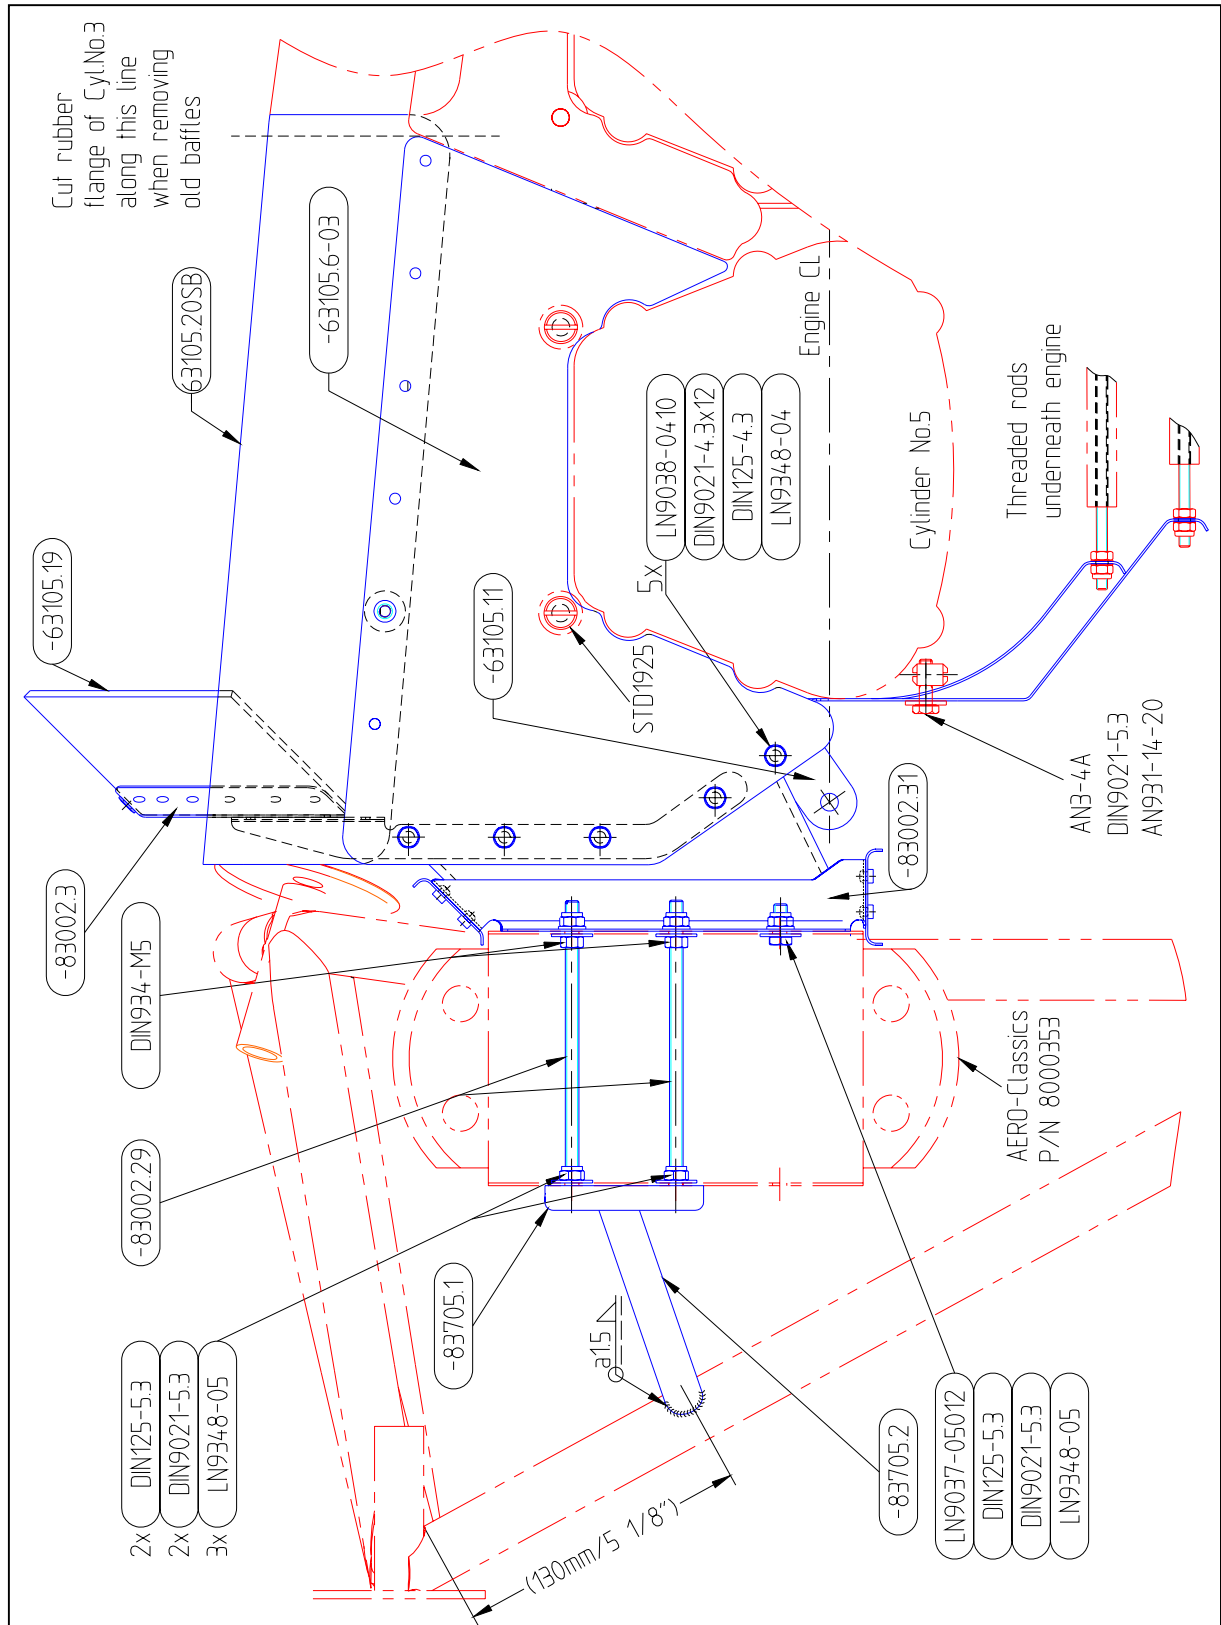
Figure 4: Side view of oil cooler installation on engine mount

- Bolt the preassembled RH cylinder head baffle (P/N EA-63105.6-03) to the preassembled RH AFT Baffle (P/N EA-83002.3) according to Figure 4.
- Install the baffle attachment plate (P/N EA-63105.11) on the engine, see Figure 4.

- Determine the position of the hole, needed to bolt the baffle to the engine (Cylinder No.5), located on the lower outboard side of the RH AFT baffle (P/N EA-83002.3). Drill the (Ø5mm, Drill Size #8)-hole in the baffle and insert original bolt and washer, see Figure 4.

- Install threaded rods (P/N EA-83002.29) on oil cooler and temporarily install oil cooler according Figure 4.

- Install assembled baffles according Figure 4. The pre-cut baffle rubber on the RH middle cylinder head (Cylinder No.3) has to be cut to exactly fit the new installation.
- Attach preassembled oil cooler duct (P/N EA-83002.31) to the oil cooler and finalize oil cooler installation.
- Install oil separator in its new orientation.
- Reinstall oil line between oil valve and engine and connect the oil line to the engine mount with two tiedown straps.
- Reinstall bulkhead fitting (use AN837-4D) and reconnect fuel sensing lines, see Figure 6.
- Reconnect battery ground wire as well as engine ground wire to the firewall.
- Reinstall upper and lower engine cowling and LH landing gear cuff.
- Make appropriate logbook entry of compliance with this Service Bulletin.

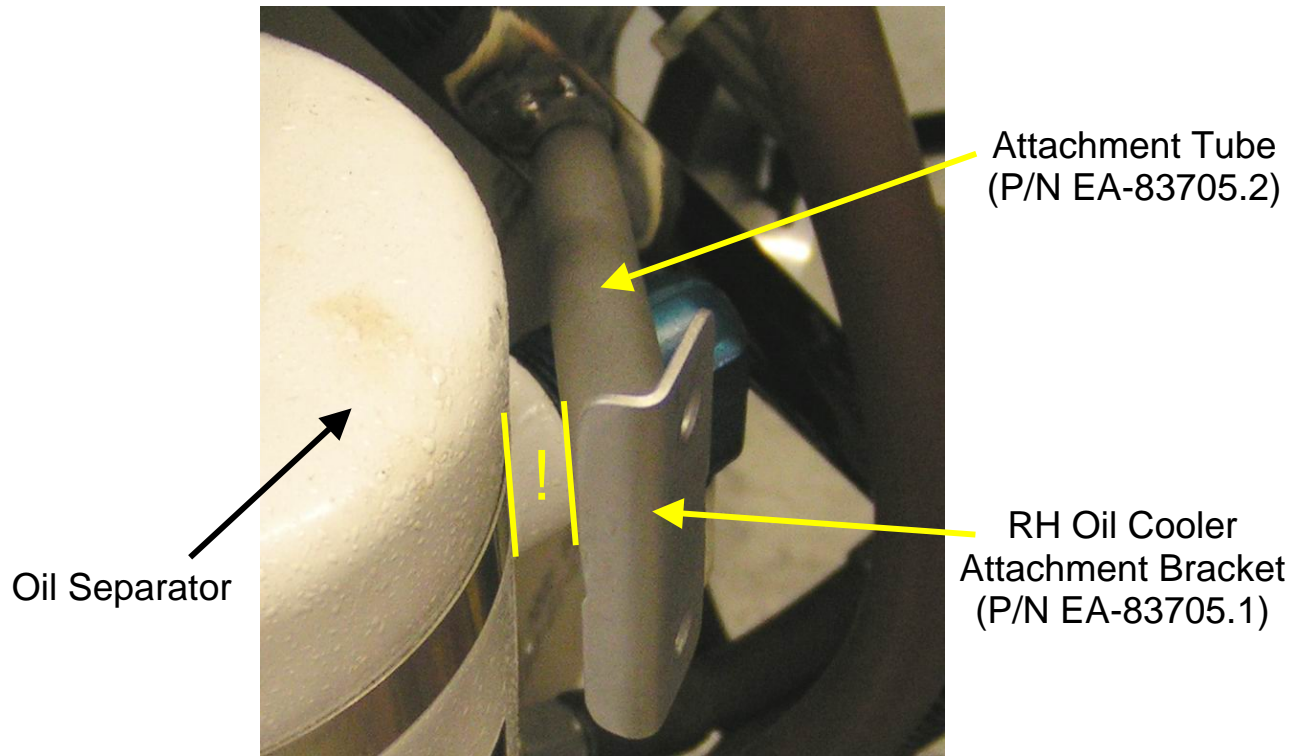
Figure 5: Separation between oil separator and attachment tube.

- Spot weld the LH oil cooler attachment bracket (P/N EA-83705.10) to vertical tube of engine mount.
- Prepare the attachment tube (P/N EA-83705.2) to fit between the RH oil cooler attachment bracket (P/N EA-83705.1) and the engine mount according Figures 3 & 4. Check for enough space between tube and oil separator (temporarily installed for this purpose) and its fittings, see Figure 5. Here, the oil separator is installed rotated 15° CCW when viewed from above relative to its original position to provide enough separation between the middle fitting and the oil cooler. The upper fitting has to point in its original direction i.e. has to be rotated 15° CW when viewed from above.

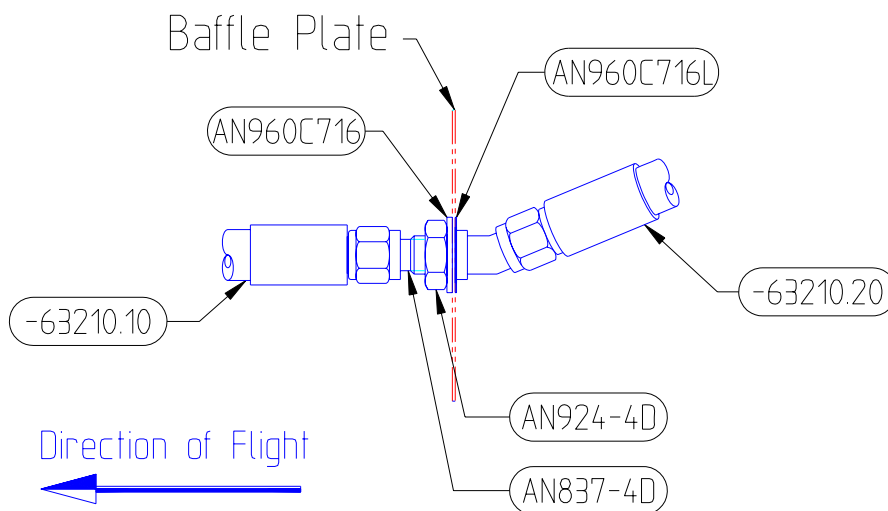
Fig. 6: Bulkhead Fitting Fuel Sensing Line Installation

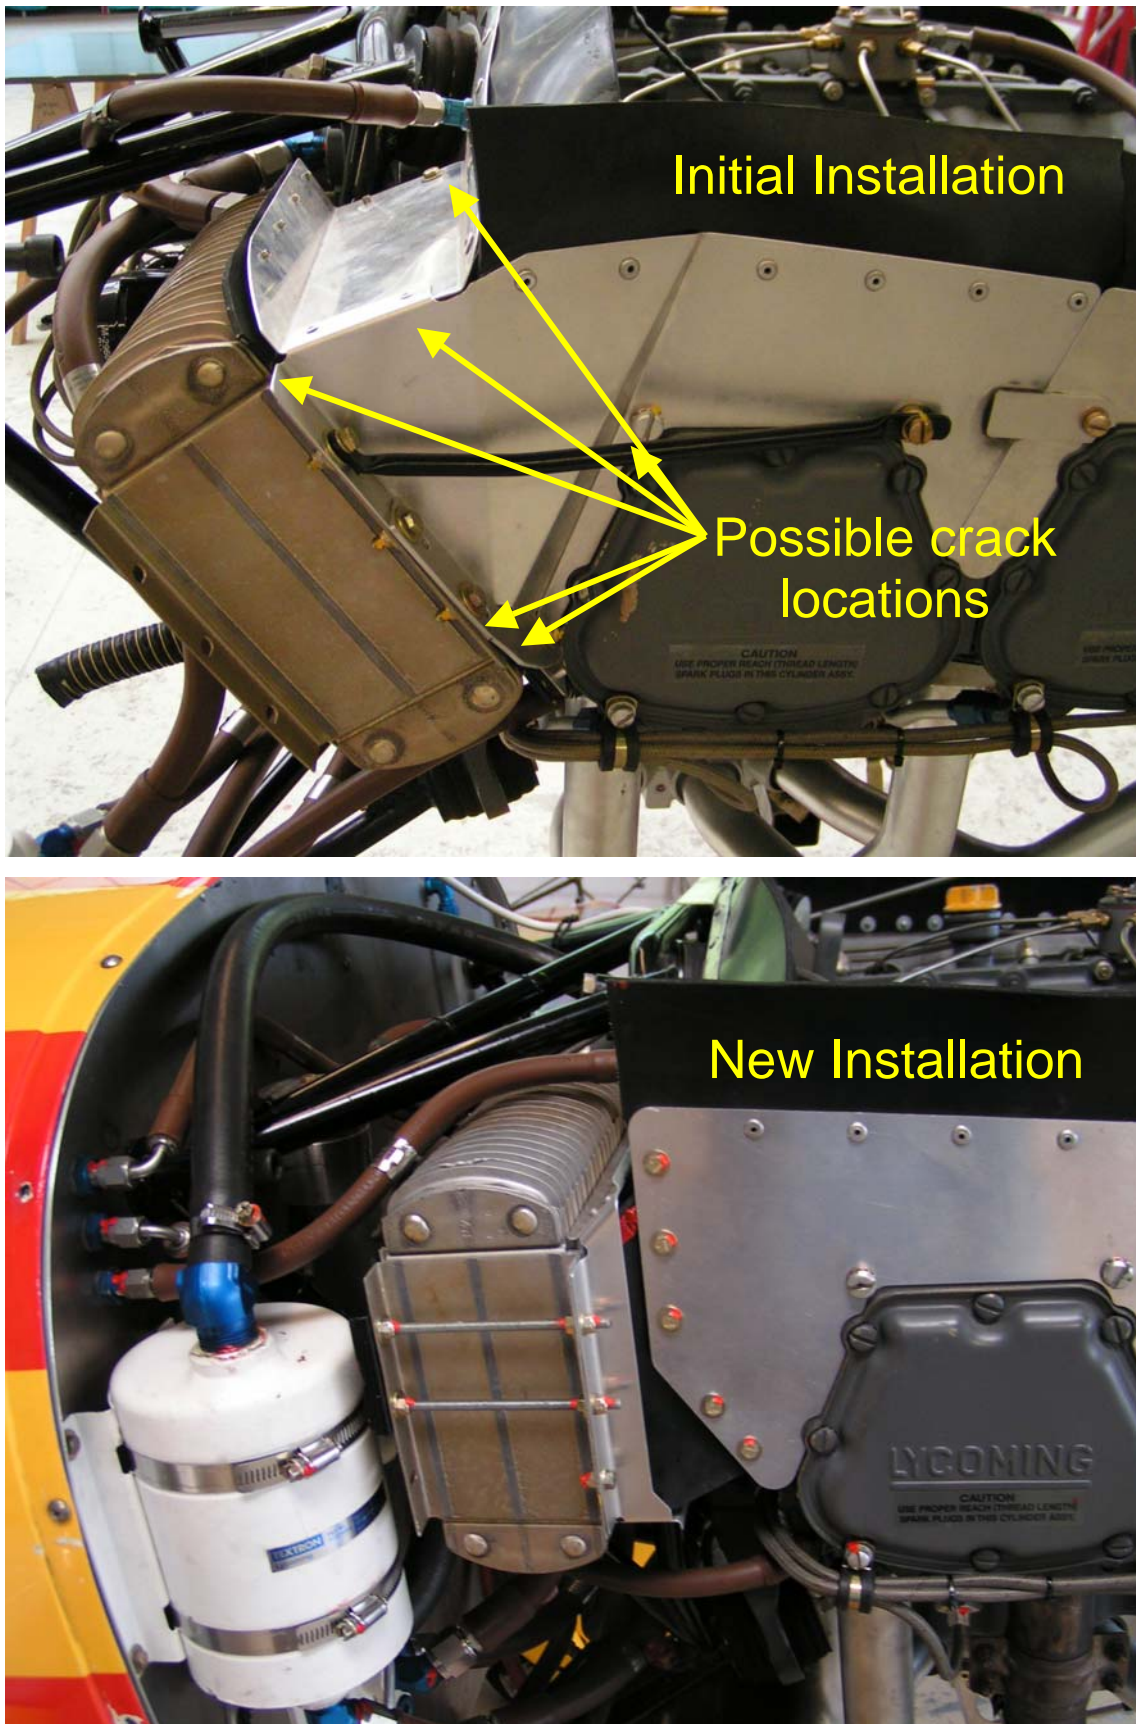
- Purpose:** Cracks have been reported on EA 300/S and EA 300/L airplanes equipped with the single oil cooler system. The cracks were found in the RH AFT engine cooling baffles where the oil cooler is attached to or in the oil cooler flanges. This Service Bulletin provides instructions for repositioning of the single oil cooler from the cylinder cooling baffles to the engine mount. Refer to Figure 7 for an overview.

Fig. 7: Possible crack locations on current installation and view of new installation.
