SERVICE BULLETIN

No. SB-300-1-22

- SUBJECT:** Non-destructive inspection (NDI) of fuselage primary structure
- AFFECTED:** EXTRA EA 300/SC
- Purpose:** Cracks in LH upper fuselage longeron tube just aft of the attachment bushing for engine mount support have been reported on two airplanes that are frequently operated at the design limits. This Service Bulletin provides instructions for additional non-destructive inspection (NDI) of fuselage steel tube structure for airplanes which are heavily operated at the edge of given operating limitations during most of the flight time.

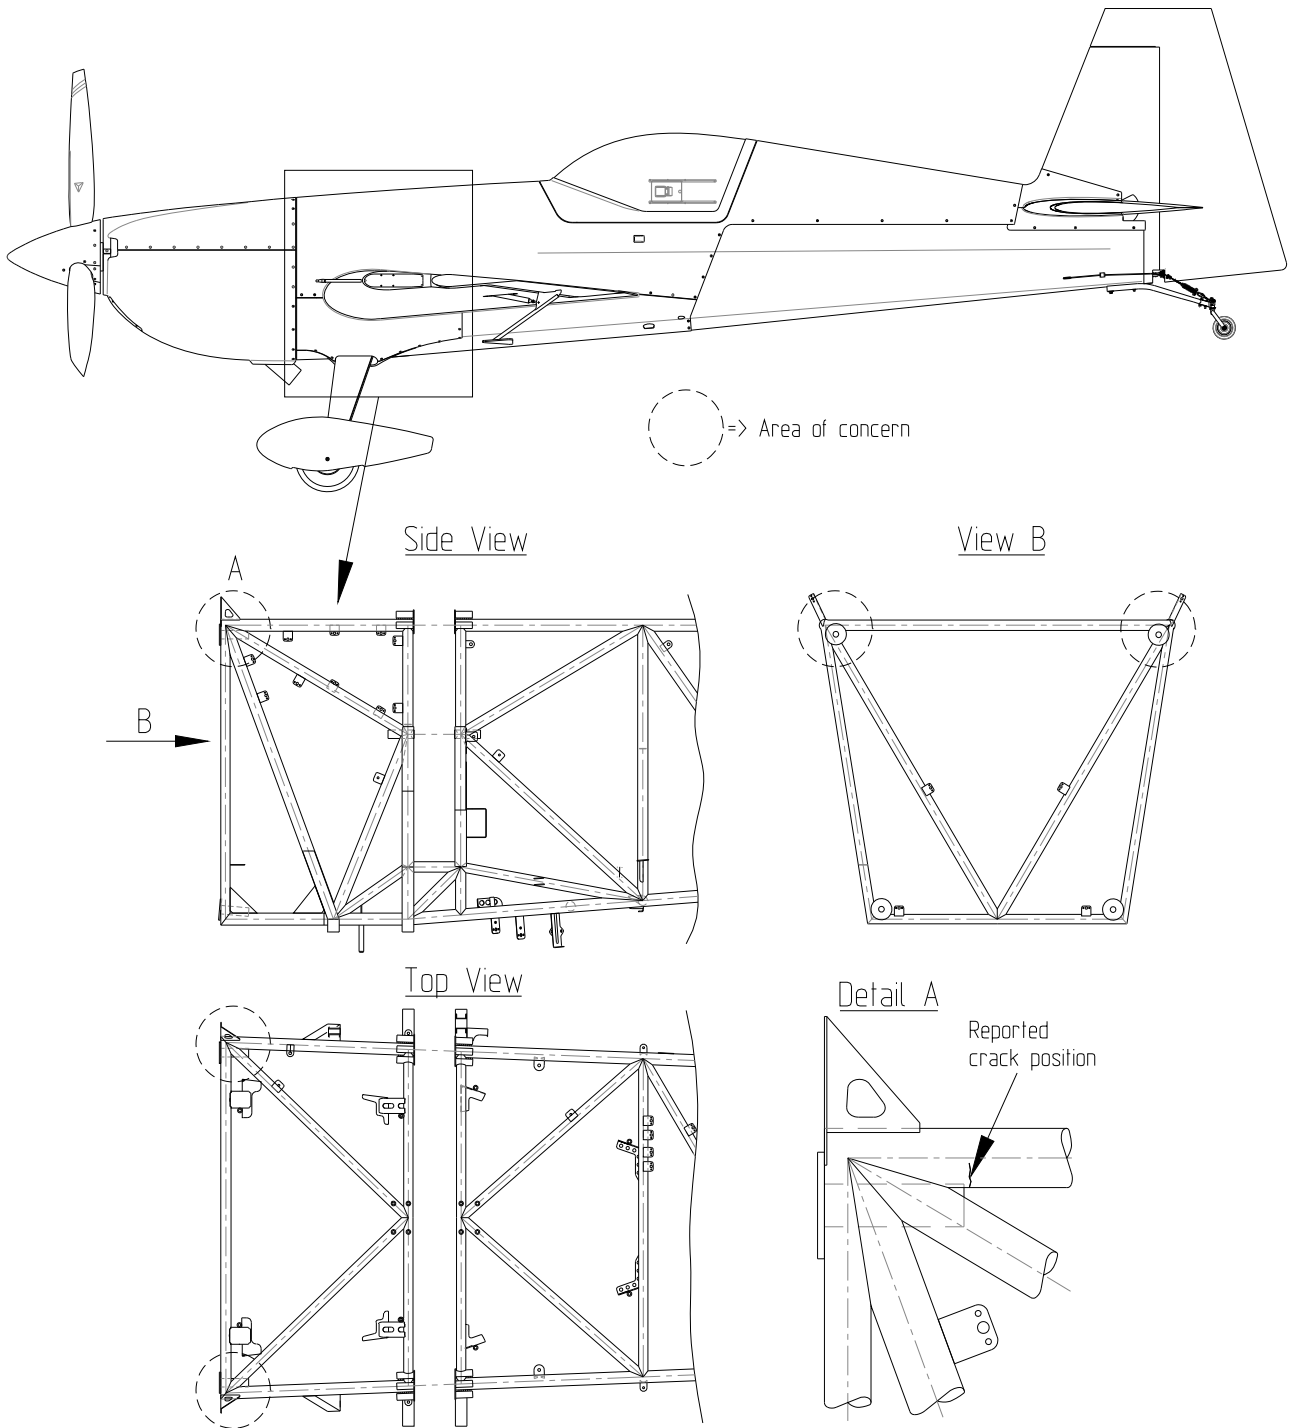
Cracks have been reported on two EA 300/SC airplanes that are frequently operated near, at or slightly beyond design limits. A crack was found in the LH upper fuselage longeron tube just aft of the attachment bushing for engine mount attachment within the regular inspection intervals. To that time both airplanes have reached a service time beyond 3000 hours with more than 4600 landings. They are flown in many acrobatic competitions (e.g. World Acrobatic Championship [WAC]) and air shows accompanied with required high numbers of training flights. These two airplanes in particular are heavily operated at the edge of given operating limitations during most of all the flight time. Based on the knowledge gained by those reported occurrences, it seems that operation frequently at limit load level and furthermore cumulative effects of aggressive operating maneuvers will have an adverse effect on the structural capability of the fuselage steel tube frame of the EA 300/SC type design.

Figure 1: Area of fuselage steel tube structure to be nondestructive inspected

- Remove engine cowling, canopy and main fuselage cover (see Chapters 71-10-00, 53-00-10, 51-00-01)
- Perform detailed visual inspection of steel tubes of the fuselage primary structure in the area of attachments bushings to the engine mount structure. Carefully check for any damage (dents, cracks, deformations etc.) especially at welds (*Refer to Figure 1*).
Pay special attention to the lower side of the LH & RH longeron tube (dim. 25x1.5mm) just aft of the engine mount attachment.
Note:
In case of any doubt: Check steel tubes of uncertain areas using a Liquid/Visible or Fluorescent Dye Penetrant inspection method to ensure no cracks are evident.
Applicable Technical Standards should be considered for that purpose (*see Appendix A*).
- Reassemble engine cowling, canopy and main fuselage cover (see Chapters 71-10-00, 53-00-10, 51-00-01)
