SERVICE BULLETIN

No. SB-300-2-22

SUBJECT: Recurrent inspection of elevator trim tab

AFFECTED:	EA 300	(EXTRA 300)	all S/N
	EA 300/S	(EXTRA 300S)	all S/N
	EA 300/L	(EXTRA 300L)	all S/N
	EA 300/LT	(EXTRA 300LT)	all S/N
	EA 300/LC	(EXTRA 330LX)	all S/N

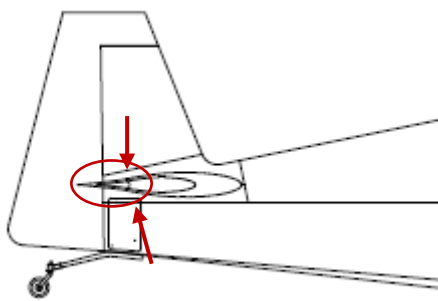
Figure 1 – EA 300 tail section right side view:
area subject to inspection

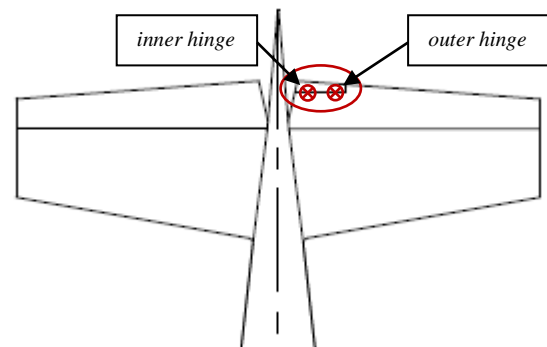
Figure 2 – EA 300 tail section bottom view:
area subject to inspection

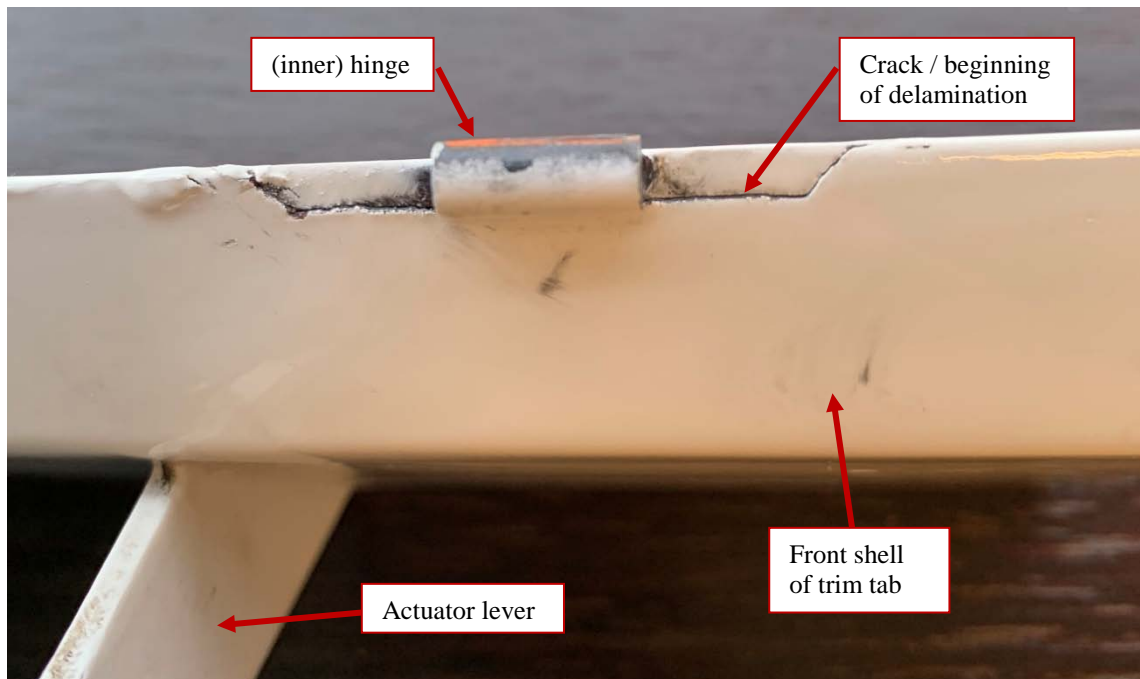
Purpose: Cracks within the glue joint between the hinge bracket and the upper/lower shell and web of the elevator trim tab have been reported. Cracks grew left and right of the hinge position into the leading edge bond of the tab. In one case, the trim tab was finally detached from the elevator in flight.
This Service Bulletin (SB) provides information for additional recurrent inspection of the affected area in order to detect any upcoming issue at an early stage and to prevent loose condition of trim tab hinges that may result in elevator trim tab failure.

Figure 3 – Trim tab inner hinge (front view) with cracks / beginning of delamination

- Set elevator trim to full nose down position for ease of inspection.
- Perform detailed visual inspection of trim tab hinges and area around hinges for damage, cracks, excessive wear and tear and delamination at given compliance time.
An example of progressing damage of a trim tab hinge is shown in Figure 3 below.
- Please report outcome of first inspection as per this Service Bulletin regardless of result, and further recurring inspection in case damage is found, to EXTRA by returning a copy of the completed Form in Appendix A.
- Make a permanent note of the execution of this inspection in the aircraft logbook.
