SERVICE LETTER

No. SL-NG-2-22

Subject: FWD Tail Spring Attachment Bracket

Aircraft affected: EXTRA NG: S/N NG001 through NG041.

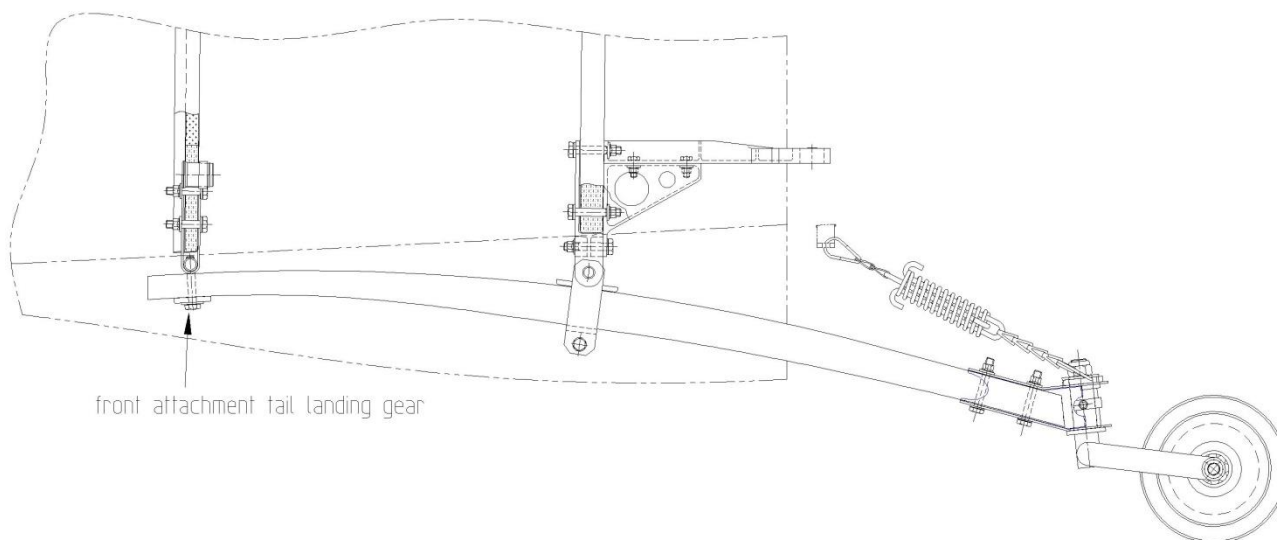
Purpose: A failure of a forward attachment bracket (PN EX-21451.02) of the tail landing gear spring during landing roll at taxi speed was reported on one airplane.

A proactive design change of the forward attachment bracket is made available to customers on demand. This improved bracket can be used as direct exchange part/replacement of the original bracket installed.

This Service Letter (SL) provides information for a recommended replacement of the respective bracket.
