SERVICE BULLETIN

No. SB-NG-2-22

Subject:	Canopy Frame Improvement
Aircraft affected:	EXTRA NG: S/N NG001 through NG038, except for NG026.
Purpose:	<p>An improvement of the bonding between the inner and outer canopy frame shall be introduced.</p> <p>Although there is currently no reason to assume that the canopy of the aircraft requires any technical modifications, as a mere precautionary measure the carbon fibre canopy frame shall be further improved and strengthened by reworking of the adhesive glue bonding between the inner and outer canopy frame.</p>
Approval:	The technical content of this document is approved under the authority of the DOA ref. EASA.21J.593.

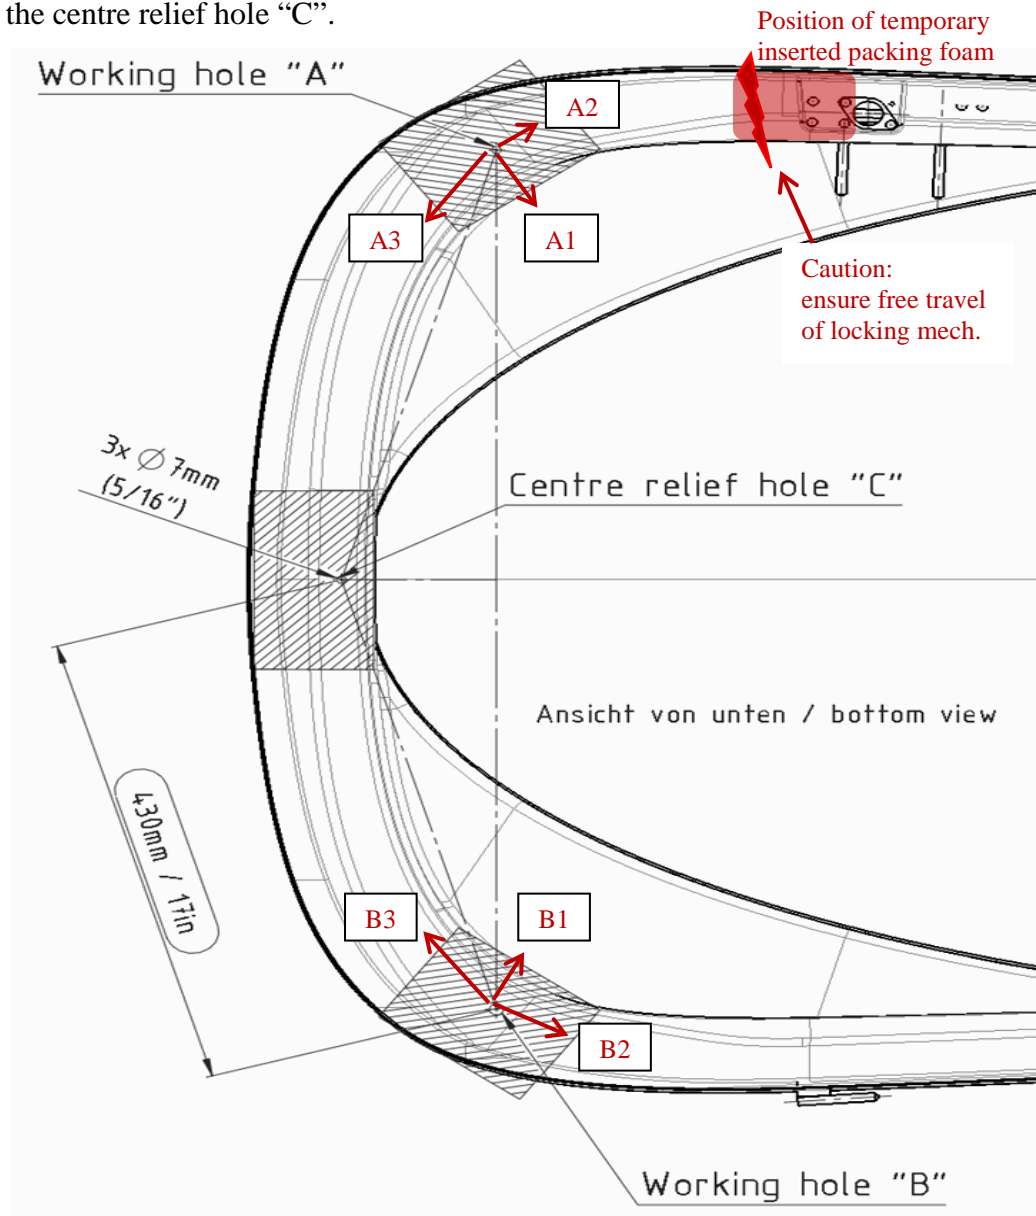
Figure 1 Canopy – bottom view

Deviation from the below instructions, notably from the given sequence or by applying too much foam, may lead to permanent deformation of the slightly curved canopy frame surfaces and/or may block the locking mechanism or the centre relief hole “C” before the entire procedure is completed.

Take care not to block the locking mechanism by applying too much foam towards direction A2.

In case the centre relief hole “C” gets already fully blocked by foam, drill a new pressure relief hole in between holes “B” and “C” (as close to “C” as possible to still get unblocked access from “B”)

5. Carefully drill 3 holes with \varnothing 7mm / 5/16in into the inner frame of the canopy as per Figure 1 below. Clean area around drill holes with vacuum cleaner.

6. Thoroughly protect the area around the three holes with tape (see shaded area in Figure 1).
7. Pull locking handle to open position and hold or temporarily fixate, then insert strip of packing foam into the front most latch opening towards the front in order to create a barrier between the locking mechanism and the drilled hole “A”. Make sure you can pull the packing foam out again later and the locking handles can still be moved freely after the handle is released.

9. Insert tube approximately 100mm / 4in into working hole "A" (locking side, see Figure 1) directed towards the slightly curved area (direction A1, inwards). Apply 1 short push on the trigger.
10. Immediately pull the tube until just before pulling fully out, turn left (~90°) and stick further in again by approximately 50mm / 2in alongside the frame facing towards the previously inserted packing foam barrier (direction A2), apply another *very* short push on the trigger.

11. Again, immediately pull almost out, turn ~180° and push back in approximately 100mm / 4in alongside the frame facing towards the centre relief hole "C" (direction A3). Push trigger until the foam can be seen through the centre relief hole "C".

12. Repeat procedure on the opposite side with working hole “B”:
 - a. Insert tube approximately 100mm / 4in into working hole “B” (hinge side, see Figure 1) directed towards the slightly curved area (direction B1, inwards). Apply 1 short push on the trigger.

- b. pull the tube until just before pulling fully out, turn right (~90°) and push back in approximately 50mm / 2in alongside the frame facing towards the hinges (direction B2), push trigger (hinge side is not that critical regarding foam volume).

- c. Again, pull almost out, turn ~180° and push back in approximately 100mm / 4in alongside the frame facing towards the centre relief hole “C” (direction B3). Push and hold trigger until the foam can be seen through the centre relief hole “C”.
