SERVICE BULLETIN

No. SB-NG-1-23

Subject: Improvement of main landing gear attachment

Service Bulletin EXTRA NG Main Gear Attachment

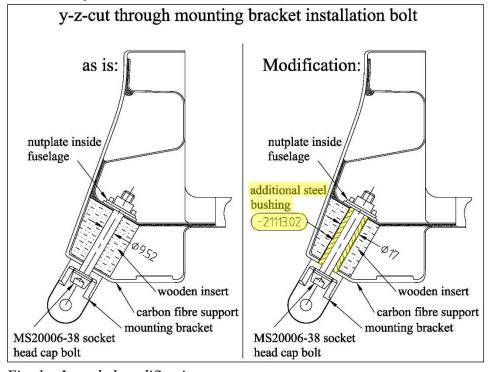
Fig. 1 – Intended modification

In few cases the current design of the main landing gear attachment has settled, resulting in minimal gaps between the bracket and the adjacent structure

As a precautionary measure, the carbon fibre support for the main landing gear leg shall be improved and strengthened by addition of a steel bushing.
