## SERVICE BULLETIN

### No. SB-NG-2-23

**Subject:** FWD Tail Spring Attachment Bracket

**Aircraft affected:** EXTRA NG: S/N NG001 through NG040,  
except related SL-NG-2-22 was already complied with.

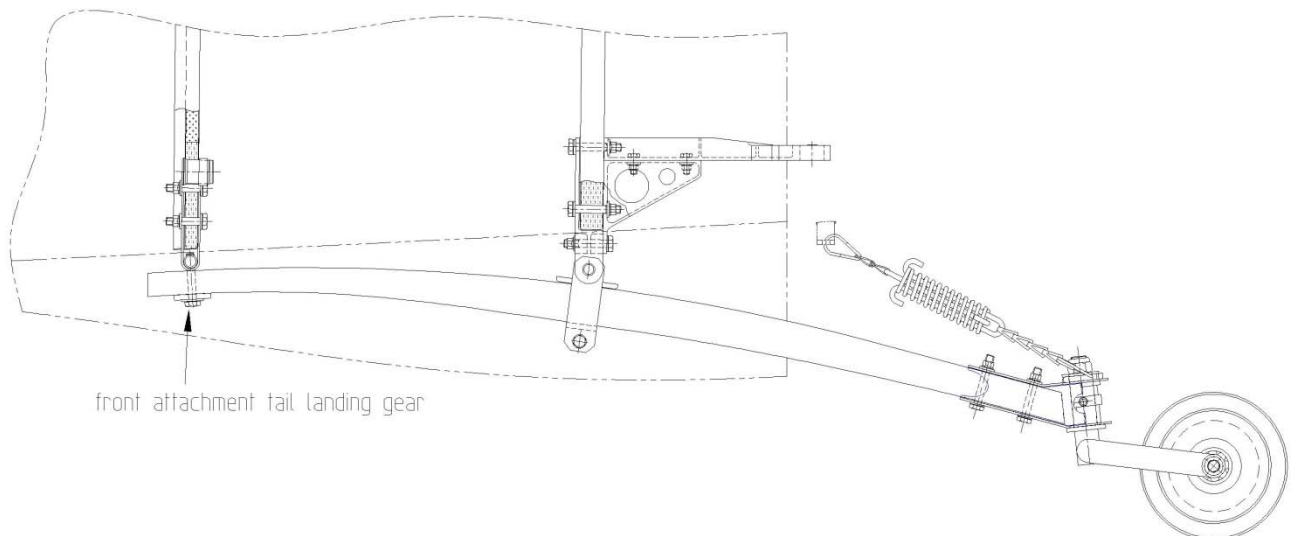
**Purpose:** The failure of a forward attachment bracket (PN EX-21451.02) of the tail landing gear spring during landing roll at taxi speed was reported on two airplanes.

A design change of the forward attachment bracket is made available. This improved bracket can be used as direct exchange part/replacement of the original bracket installed.

This Service Bulletin (SB) provides information for the replacement of the respective bracket.
