SERVICE BULLETIN

No. SB-NG-1-24

Subject: Canopy-Placard

Aircraft affected: EXTRA NG: S/N NG002 through NG064.

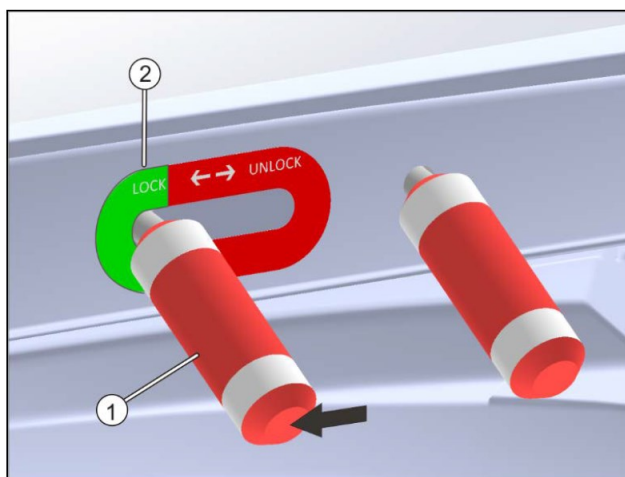
A design change of the canopy placard around the cutout for the movable (rear) canopy locking handles (1) in both cockpits was already introduced as an alternative, improved means of visualization of the canopy locking condition. EXTRA decided that the improved canopy placard should be the only version to reduce the misuse of the canopy locking and thus to avoid a potential unsafe condition. For that purpose all placards of the initial design (applied to canopies up to serial n° 071) shall be replaced by the improved version (2).

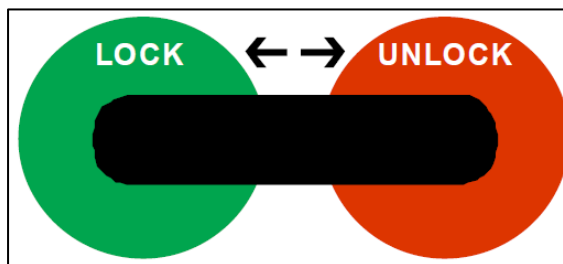
Fig. 1: Canopy placard – initial design

Only canopy placards of the initial design need to be replaced. In case the current improved design as per Fig. 2 is already installed, no action is required.

1. Remove canopy placards at both front and rear canopy handles. Clean area around cutout and remove all residue from old placard adhesive.
