## SERVICE BULLETIN No. 300-2-93

Subject: Wing Root Rib / Auxiliary Spar Attachment

Models affected: EA-300 EA-300/S

**Service Bulletin**  
**EA-300 & EA-300/S**

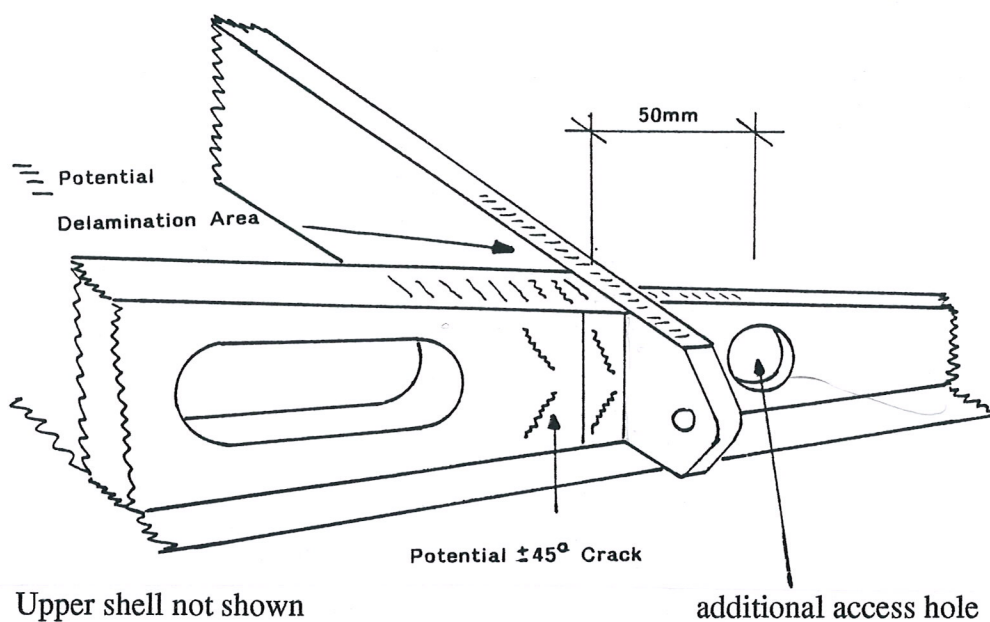
Fig.: Potential Delamination Areas

- Particular attention shall be payed to the thickened resin glue joint between the composite root rib and the auxiliary spar. Possible cracks are visible as  $\pm 45^\circ$  degree lines. In case of doubt remove the black color on the outside of the composite root rib by a paint solvent or corrosive agent (do not sand to remove color!).

- Delaminations of the shell to auxiliary spar glue joint are likely to be detected by coin tapping close to the shell edge. Delaminations and cracks which make the retrofit as described below necessary are seen as fine lines along the edge of the glue joint.

- In case delaminations are existent between the root rib webs and root rib sandwich core they are visible as "white" areas.

- In case cracks or delaminations are found in this area contact Extra Flugzeugbau GmbH for advise.

- The structural retrofit is necessary in case cracks and delaminations are found. The retrofit is being life cycle tested.
- Order Extra Part N°: PC-13105.8 for EA-300 or PC-14105.8 for EA-300/S and install according to assembly instruction AI-300-1-93 or AI-300/S-1-93 respectively.
