SERVICE BULLETIN

No. 300-1-01

Subject: Securing the wire stirrup of the gascolator bowl

Aircraft affected: EA-300 S/N 1 - 67
EA-300/L S/N 1 - 133
EA-300/S S/N 1 - 30
EA-300/200 S/N 1 - 29

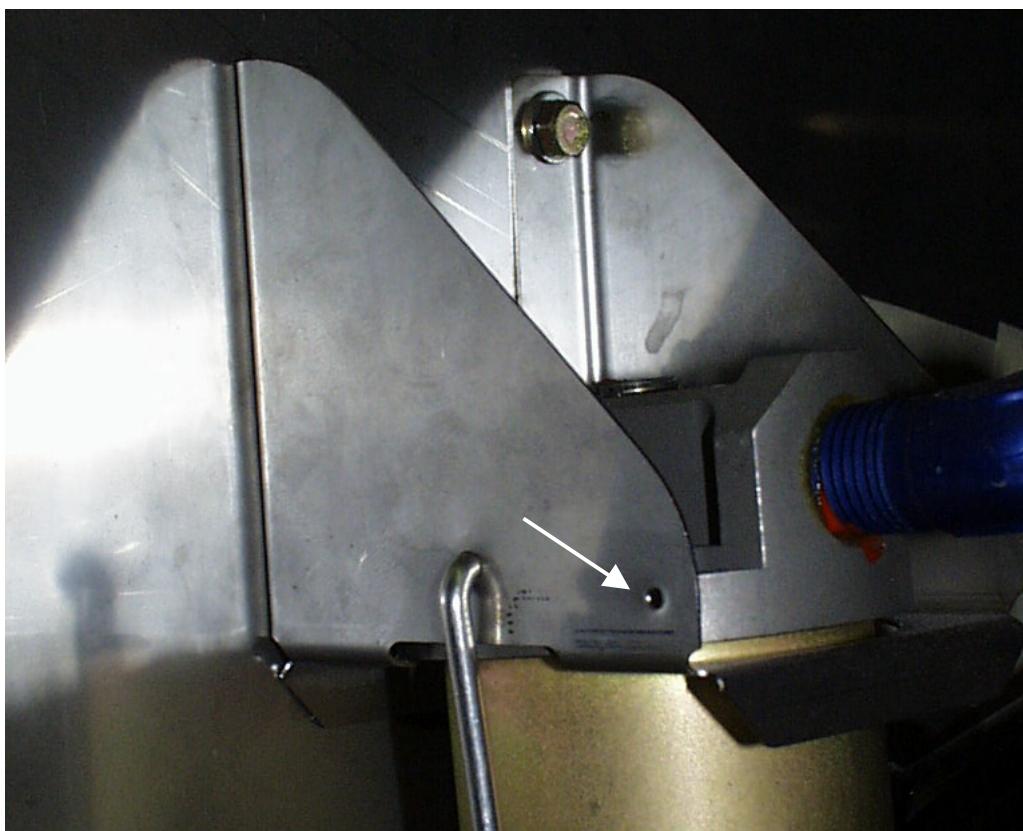
Picture 1

Purpose: Safety wiring prevents the wire stirrup from migrating outwards, causing the possibility of an unseated gascolator bowl.

- Drill a hole (3/32“, 2mm) into the bracket (see picture 1).
- Saftetywire the stirrup according the picture 2 below. Use safety wire dia. 0.032“.
- Make appropriate entry of compliance with this service bulletin in the aircraft log.
